Appendix I1
Accessibility
Audit Report

Jacobs Engineering Ireland Limited

As a part of the Engineering Design Services for the Preliminary Design and Planning Stage, through to the end of the Statutory Process of the BusConnects Radial Core Bus Corridors Infrastructure Programme, an audit of the existing infrastructure provided for people with disabilities along the proposed Bray to City Centre Core Bus Corridor (CBC) has been carried out. This report outlines the standards and guidelines that should be used to provide suitable infrastructure for people with disabilities, the process and outcomes of the audit and recommended improvements that will bring the existing infrastructure up to standard.

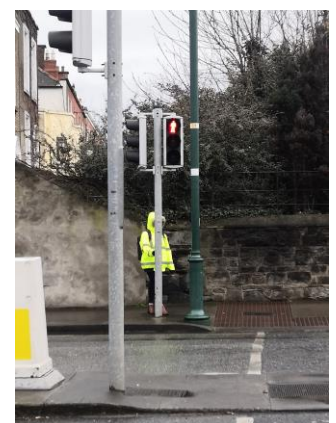
Figure 2.4: Lamp post in footpath

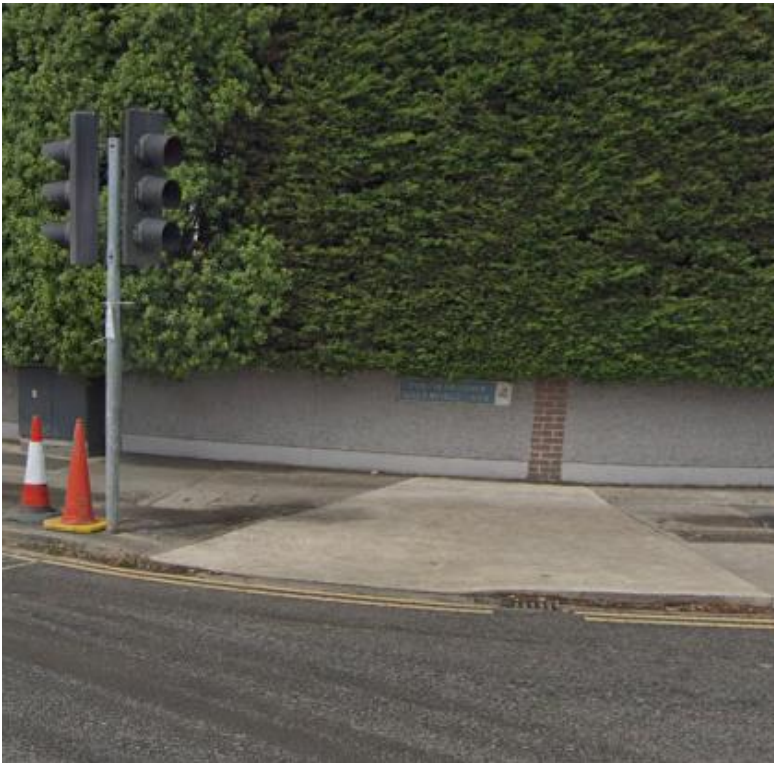
While all the tactile paving in this section appears to be of the correct layout, the western arm of Greenfield Park is missing tactile paving, as in

Figure 2.7: Missing tactile paving

There are no other notable issues in this section of Section 1, however it is recommended that any trip hazards in the footpath or kerbs are repaired, any incorrect or missing tactile pavings are amended and any incomplete push buttons are repaired.

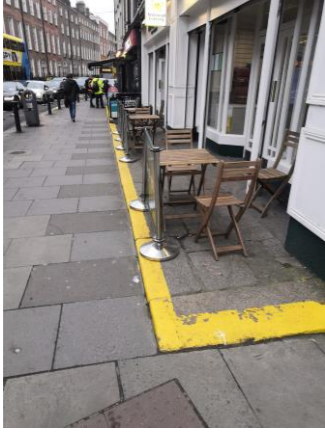
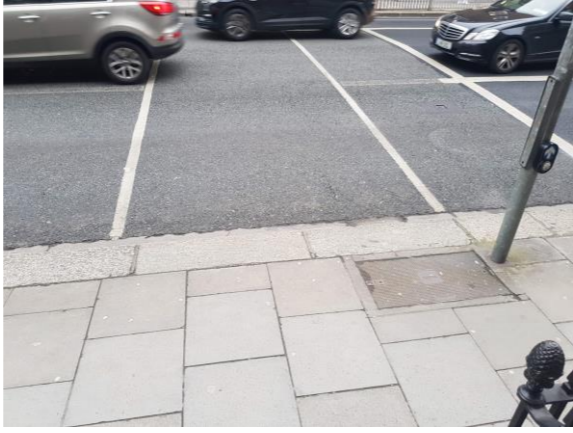
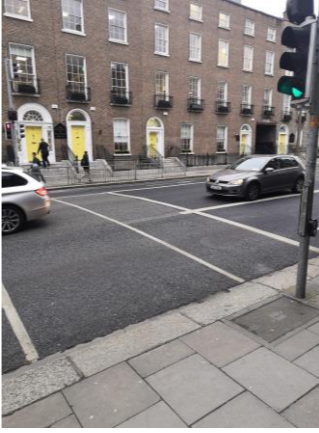
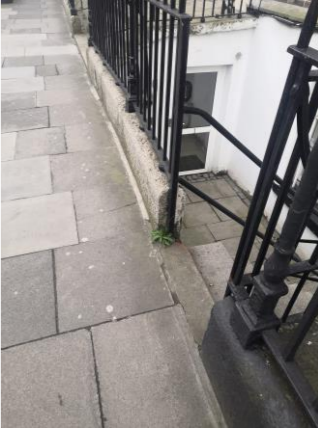
8 - Unsuitable access for disabled users	17 - No tactile paving at crossing	18 - No dropped kerbs at crossing	25 - Unsuitable access for disabled users
<p>This is located on Leeson Street Lower outside buildings 1, 2 & 3. It is considered high severity as there is a large and sustained trip hazard.</p>	<p>This is located on Leeson Street Lower. It is considered high severity as a lack of tactile paving makes visually impaired pedestrians unaware of the presence of the crossing.</p>	<p>This is located on Leeson Street Lower. It is considered high severity as a lack of tactile paving makes visually impaired pedestrians unaware of the presence of the crossing and can also introduce a trip hazard.</p>	<p>This is located on Leeson Street Lower. It is considered high severity as there is a below-ground building entrance with no hazard warning for visually impaired pedestrians.</p>

<p>716073, 733174</p>	<p>716168, 733049</p>	<p>716170, 733053</p>	<p>716176, 733023</p>
<p>Solution: Provide a barrier between the seating and the footpath or provide a grade difference to make the edge of the footpath clear.</p>	<p>Solution: Provide tactile paving at this crossing.</p>	<p>Solution: Provide a dropped kerb at this crossing.</p>	<p>Solution: Either provide tactile paving or a level difference so that disabled users can determine the edge of the path.</p>
27 - No tactile paving at crossing	29 - Insufficient footpath width	31 - Unsuitable access for disabled users	32 - Unsuitable access for disabled users
<p>This is located on Hatch Street Lower at the junction with Leeson Street Lower. It is considered high severity as a lack of tactile paving makes visually impaired pedestrians unaware of the presence of the crossing</p>	<p>This is located on Leeson Street Lower south of the junction with Hatch Street Lower. It is considered high severity as it makes the path inaccessible to people using wheelchairs or walking aides.</p>	<p>This is located on Leeson Street Lower south of the junction with Hatch Street Lower. It is considered high severity as there is a below-ground building entrance with no hazard warning for visually impaired pedestrians.</p>	<p>This is located on Leeson Street Lower south of the junction with Hatch Street Lower. It is considered high severity as there is a below-ground building entrance with no hazard warning for visually impaired pedestrians.</p>

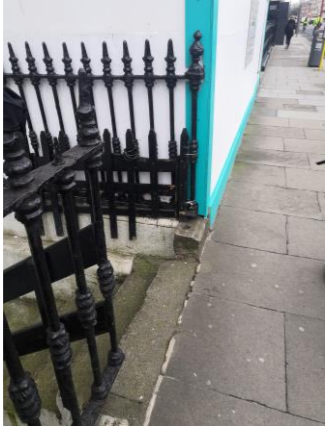
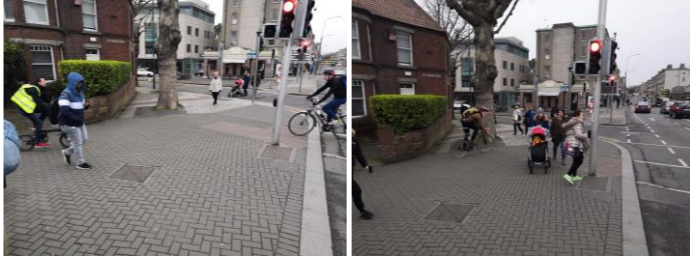
42 - Unsuitable access for disabled users	50 - Incorrect tactile paving at crossing	54 - Unsuitable access for disabled users	55 - Broken paving / footway
<p>This is located on Leeson Street Lower north of the junction with Adelaide Road. It is considered high severity as there is a below-ground building entrance with no hazard warning for visually impaired pedestrians.</p>	<p>This is located on Leeson Street Lower at the junction with Adelaide Road. It is considered high severity as incorrect tactile paving makes visually impaired pedestrians unaware of the type of crossing and could lead to dangerous crossing movements.</p>	<p>This is located on Leeson Street Lower at the junction with Adelaide Road. It is considered high severity due to the risk of collision between pedestrians and cyclists.</p>	<p>This is located on Leeson Street Lower at the junction with Mespil Road. It is considered high severity due to the presence of a trip hazard which could result in a dangerous fall into the carriageway.</p>

<p>716297, 732840</p>	<p>716337, 732788</p>	<p>716362, 732750</p>	<p>716375, 732725</p>
<p>Solution: Either provide tactile paving or a level difference so that disabled users can determine the edge of the path.</p>	<p>Solution: Upgrade tactile paving to match the current standards.</p>	<p>Solution: Provide clear markers for interactions between all users in this shared space, particularly between pedestrians and cyclists.</p>	<p>Solution: Repair paving to be even and suitable for disabled users.</p>
61 - No tactile paving at crossing	63 - No tactile paving at crossing	67 - Inappropriately constructed vehicle crossover point (multiple along stretch of road)	69 - Inappropriately constructed vehicle crossover point (multiple along stretch of road)
<p>This is located on Leeson Street Upper at the junction with Darthmouth Road. It is considered high severity as a lack of tactile paving makes visually impaired pedestrians unaware of the presence of the crossing.</p>	<p>This is located on Leeson Street Upper at the junction with Darthmouth Road. It is considered high severity as a lack of tactile paving makes visually impaired pedestrians unaware of the presence of the crossing.</p>	<p>These are located on Leeson Street Upper. They are considered high severity due to the risk of visually impaired pedestrians not being aware of the presence of a kerb and veering into the carriageway.</p>	<p>These are located on Leeson Street Upper. They are considered high severity due to the risk of visually impaired pedestrians not being aware of the presence of a kerb and veering into the carriageway.</p>

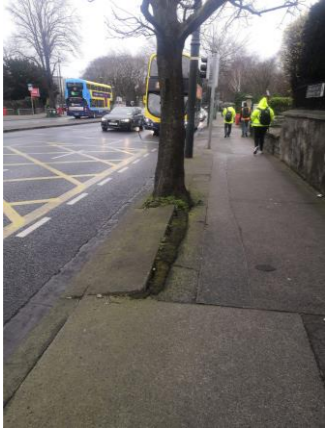
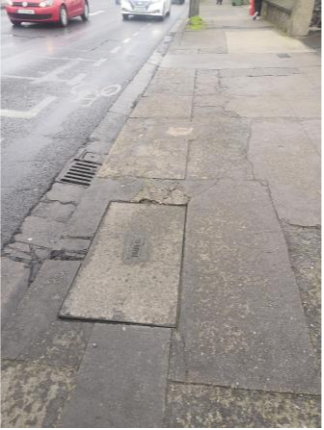
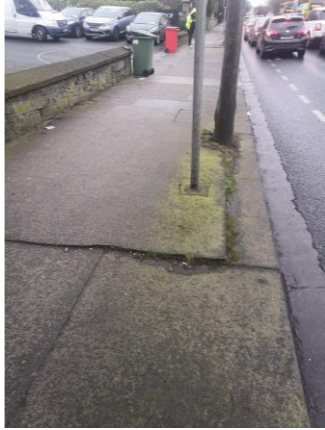
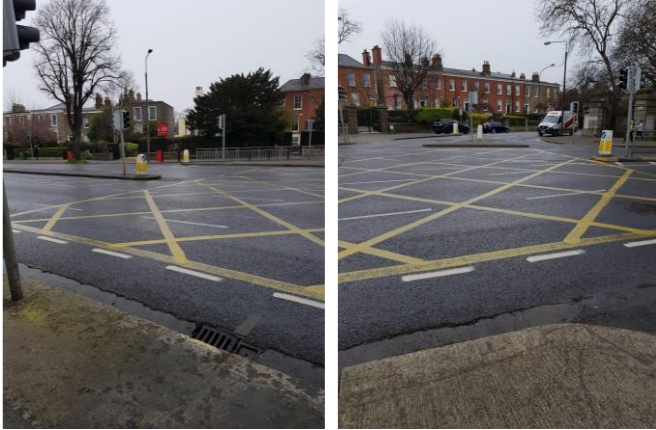
<p>94 - Broken paving / footway</p>	<p>95 - Broken paving / footway</p>	<p>97 - Broken paving / footway</p>	<p>99 - No crossing facilities provided</p>
<p>This is located on Leeson Street Upper. It is considered high severity due to the presence of a trip hazard which could result in a dangerous fall into the carriageway.</p>	<p>This is located on Leeson Street Upper. It is considered high severity due to the presence of a trip hazard which could result in a dangerous fall into the carriageway.</p>	<p>This is located on Leeson Street Upper. It is considered high severity due to the presence of a trip hazard which could result in a dangerous fall into the carriageway.</p>	<p>This is located on Morehampton Road. It is considered high severity as there are no alternatives to crossing at this point and it makes crossing inaccessible.</p>

<p>Solution: Repair paving to be even and suitable for disabled users.</p>	<p>Solution: Repair paving to be even and suitable for disabled users.</p>	<p>Solution: Repair paving to be even and suitable for disabled users.</p>	<p>Solution: Provide crossing facilities at this location.</p>
<p>103 - Broken paving / footway</p>	<p>105 - Broken paving / footway</p>	<p>106 - No tactile paving at crossing</p>	<p>120 - Broken paving / footway</p>
<p>This is located on Morehampton Road. It is considered high severity due to the presence of a trip hazard which could result in a dangerous fall.</p>	<p>This is located on Morehampton Road. It is considered high severity due to the presence of a trip hazard which could result in a dangerous fall.</p>	<p>This is located on Morehampton Road at the junction with Bloomfield Avenue. It is considered high severity as a lack of tactile paving makes visually impaired pedestrians unaware of the presence of the crossing.</p>	<p>This is located on Morehampton Road. It is considered high severity due to the presence of a trip hazard which could result in a dangerous fall into the carriageway.</p>

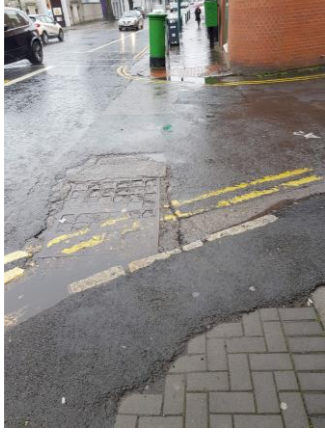
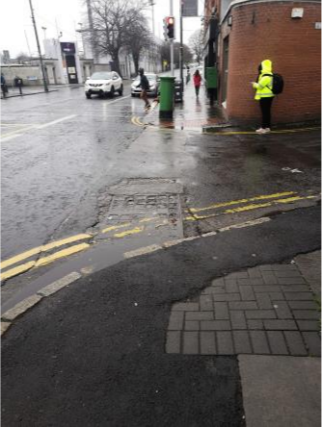
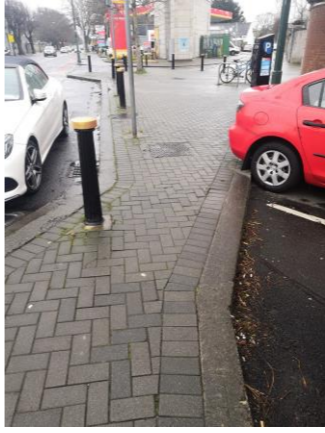
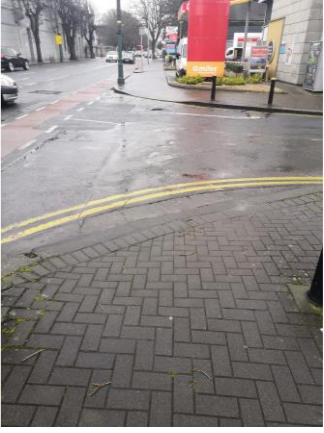
<p>164 - No tactile paving at crossing</p>	<p>167 - Crossings not aligned</p>	<p>172 - Insufficient footpath width</p>	<p>173 - No tactile paving at crossing</p>
<p>This is located on Donnybrook Road. It is considered high severity as a lack of tactile paving makes visually impaired pedestrians unaware of the presence of the crossing.</p>	<p>This is located on Donnybrook Road. It is considered high severity due to the risk of visually impaired pedestrians walking into the carriageway while trying to use the crossing.</p>	<p>This is located on Donnybrook Road opposite Energia Park. It is considered high severity as it makes the path inaccessible to people using wheelchairs or walking aides.</p>	<p>This is located on Donnybrook Road opposite Energia Park. It is considered high severity as a lack of tactile paving makes visually impaired pedestrians unaware of the presence of the crossing.</p>

<p>717575, 731586</p>	<p>717577, 731585</p>	<p>717609, 731545</p>	<p>717634, 731517</p>
<p>Solution: Provide tactile paving at this crossing.</p>	<p>Solution: Reconstruct crossing to align dropped kerbs.</p>	<p>Solution: Reposition street furniture to allow sufficient space for wheelchair users.</p>	<p>Solution: Provide tactile paving at this crossing.</p>
<p>174 - Inappropriate street furniture</p>	<p>175 - Road Surfacing at Crossing Poor</p>	<p>177 - No tactile paving at crossing</p>	<p>178 - No crossing facilities provided</p>
<p>This is located on Donnybrook Road opposite Energia Park. It is considered high severity due to the obstruction of the footway in a manner that would not be anticipated by visually impaired pedestrians.</p>	<p>This is located on Donnybrook Road crossing Brookvale Road. It is considered high severity due to the presence of a trip hazard on the road surface which could result in a fall in a dangerous location.</p>	<p>This is located on Donnybrook Road opposite Energia Park. It is considered high severity as a lack of tactile paving makes visually impaired pedestrians unaware of the presence of the crossing.</p>	<p>This is located on Donnybrook Road opposite Energia Park. It is considered high severity as there are no alternatives to crossing at this point and it makes crossing inaccessible.</p>

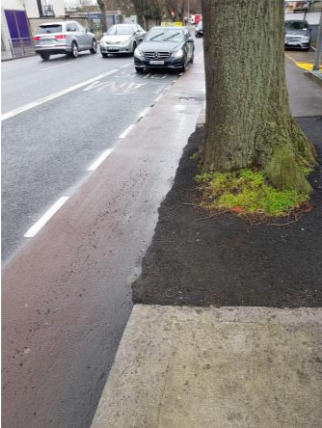
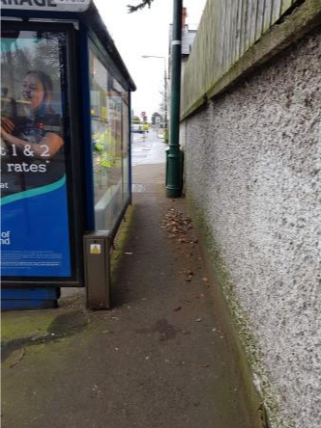
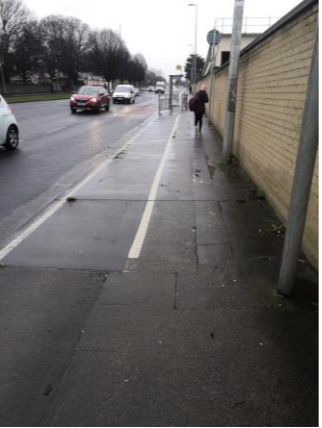
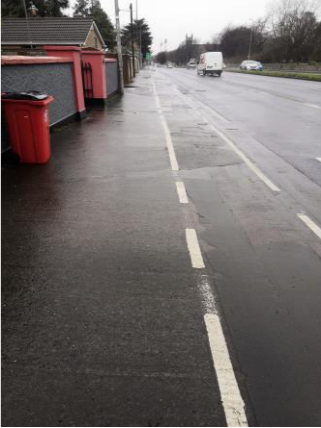
180 - Broken kerbing	183 - Insufficient footpath width	193 - No level difference between footpath and cycle lane	202 - No level difference between footpath and cycle lane
<p>This is located on Donnybrook Road. It is considered high severity due to the presence of a trip hazard which could result in a dangerous fall into the carriageway.</p>	<p>This is located on Donnybrook Road. It is considered high severity as it makes the path inaccessible to people using wheelchairs or walking aides.</p>	<p>This is located on Stillorgan Road south of the River Dodder crossing and to the west of the carriageway. It is considered high severity due to the risk of collision between pedestrians and cyclists.</p>	<p>This is located on Stillorgan Road to the west of the carriageway. It is considered high severity due to the risk of collision between pedestrians and cyclists.</p>

<p>Solution: Repair kerbing to be even and suitable for disabled users.</p>	<p>Solution: Reposition bus stop and street furniture to allow sufficient space for wheelchair users.</p>	<p>Solution: Create delineation between the footpath and cycle path.</p>	<p>Solution: Create delineation between the footpath and cycle path.</p>
212 - Incorrect tactile paving at crossing	215 - No level difference between footpath and cycle lane	220 - No level difference between footpath and cycle lane	226 - Insufficient footpath width
<p>This is located on Stillorgan Road outside the RTÉ campus. It is considered high severity as it is an in-line crossing and should have 120 cm tactiles at its narrowest point. Insufficient tactiles could result in visually impaired pedestrians missing the tiles and stepping into the carriageway.</p>	<p>This is located on Stillorgan Road to the east of the carriageway. It is considered high severity due to the risk of collision between pedestrians and cyclists.</p>	<p>This is located on Stillorgan Road south of the River Dodder crossing and to the east of the carriageway. It is considered high severity due to the risk of collision between pedestrians and cyclists.</p>	<p>This is located on Donnybrook Road. It is considered high severity as it makes the path inaccessible to people using wheelchairs or walking aides.</p>

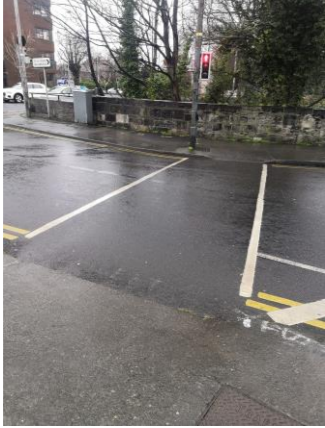
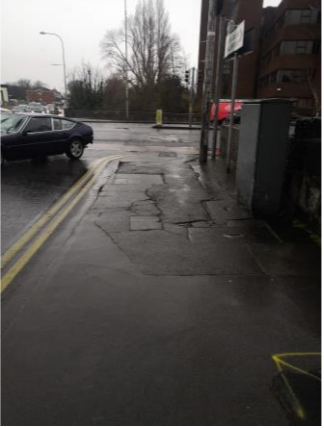
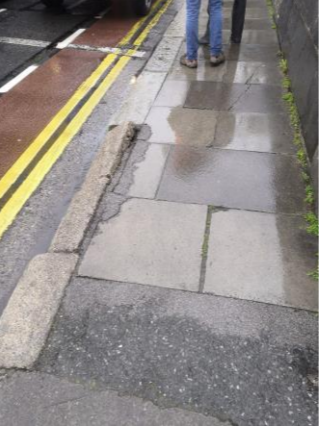
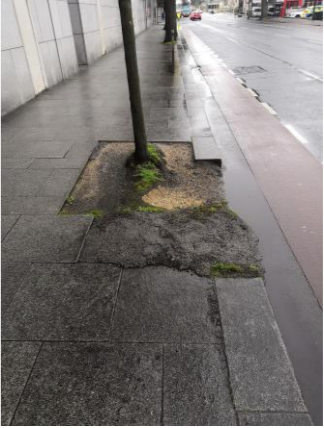
<p>227 - No tactile paving at crossing</p>	<p>228 - Broken paving / footway</p>	<p>229 - Broken kerbing</p>	<p>234 - Broken paving / footway</p>
<p>This is located on Beaver Row. It is considered high severity as a lack of tactile paving makes visually impaired pedestrians unaware of the presence of the crossing.</p>	<p>This is located on Donnybrook Road. It is considered high severity due to the presence of a trip hazard which could result in a dangerous fall into the carriageway.</p>	<p>This is located on Donnybrook Road. It is considered high severity due to the presence of a trip hazard which could result in a dangerous fall into the carriageway.</p>	<p>This is located on Donnybrook Road outside Energia Park. It is considered high severity due to the presence of a trip hazard which could result in a dangerous fall into the carriageway.</p>

<p>Solution: Provide tactile paving at this crossing.</p>	<p>Solution: Repair paving to be even and suitable for disabled users.</p>	<p>Solution: Repair kerbing to be even and suitable for disabled users.</p>	<p>Solution: Repair paving to be even and suitable for disabled users.</p>
<p>236 - Broken paving / footway</p>	<p>239 - No crossing facilities provided</p>	<p>241 - No tactile paving at crossing</p>	<p>242 - No tactile paving at crossing</p>
<p>This is located on Donnybrook Road outside Energia Park. It is considered high severity due to the presence of a trip hazard which could result in a dangerous fall.</p>	<p>This is located on Donnybrook Road outside Bective Rangers Football Club. It is considered high severity as there are no alternatives to crossing at this point and it makes crossing inaccessible.</p>	<p>This is located on Donnybrook Road. It is considered high severity as a lack of tactile paving makes visually impaired pedestrians unaware of the presence of the crossing.</p>	<p>This is located on Donnybrook Road. It is considered high severity as a lack of tactile paving makes visually impaired pedestrians unaware of the presence of the crossing.</p>

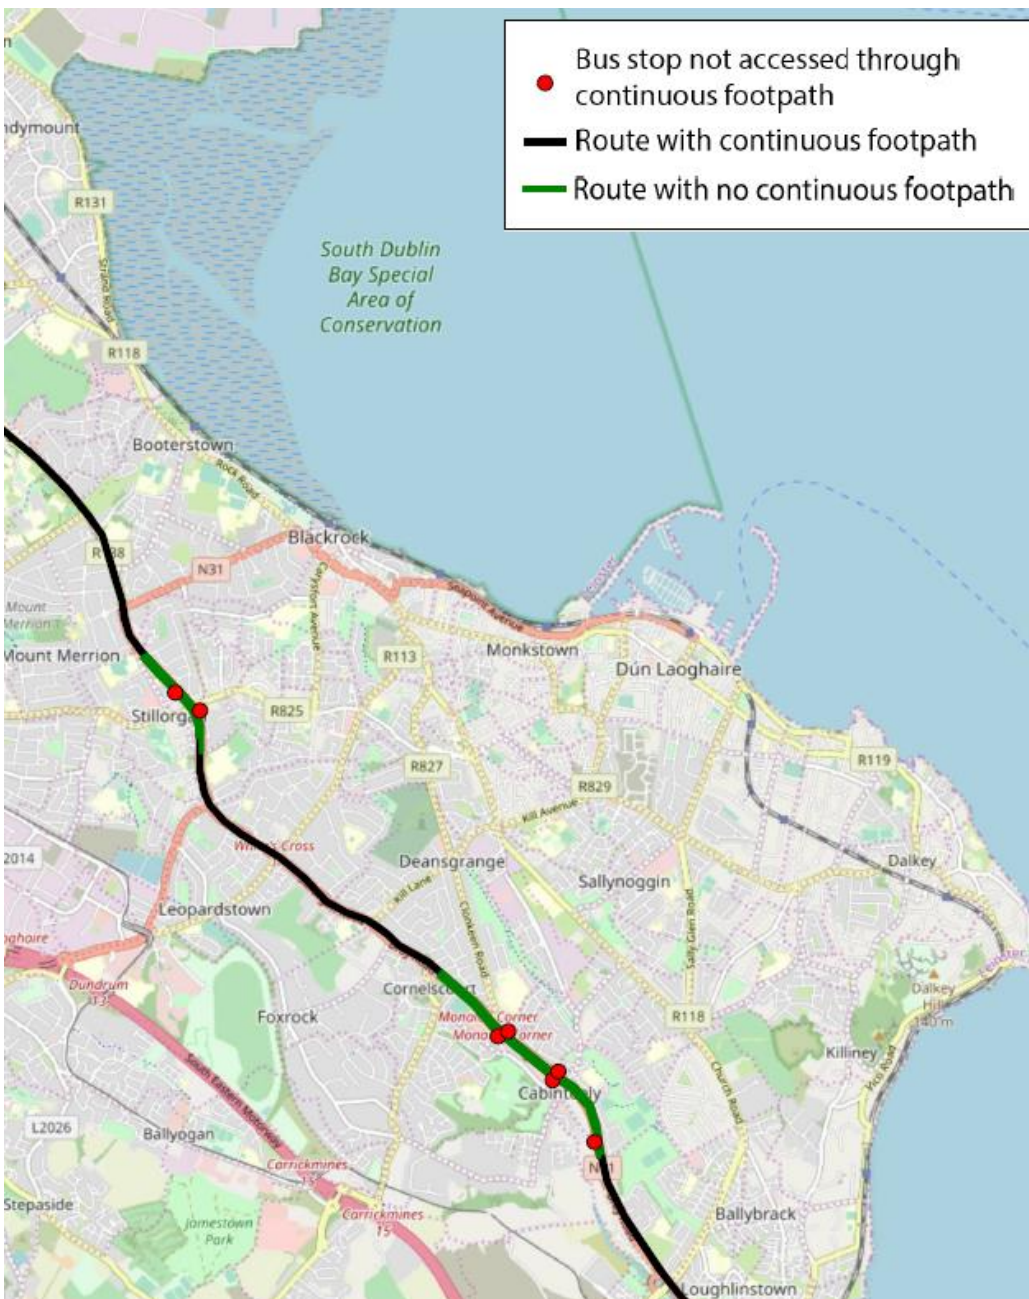
Figure 3.3 shows the section of the scheme within this section where there is no continuous footpath provided by design. These sections have either a crossing provided to the footpath on the other side, or a footway on a parallel street away from the main road, with path access to the bus stops.

Figure 3.3: Sections of the scheme with no continuous footpath

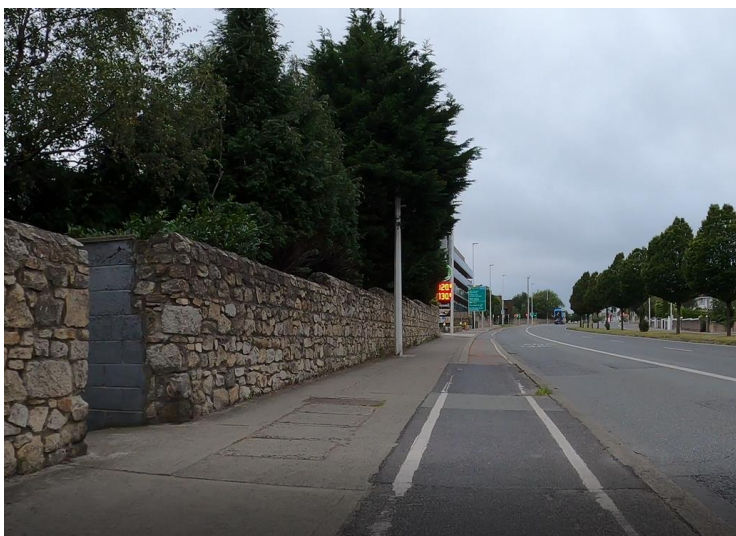
Figure 3.5: No level difference between footpath and cycle lane

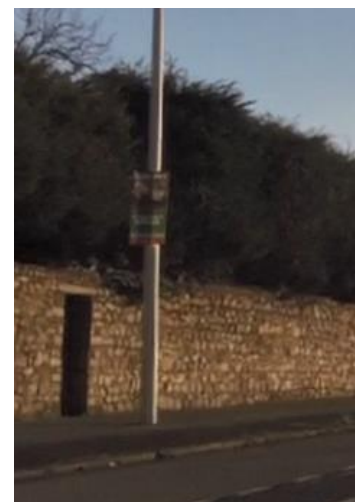
The footpath and kerbing along this section appears to be mostly of good quality throughout this section. There are two instances on the video where lamp posts appear to limit the width of the footpath below the standards allowed, Figure 3.4. It is recommended that in the design stage, all lamp posts are placed at the edge of the footpath or away from the footpath completely, where considered to limit the width of the footpath below the standards allowed.

Figure 3.4: Lamp post in footway

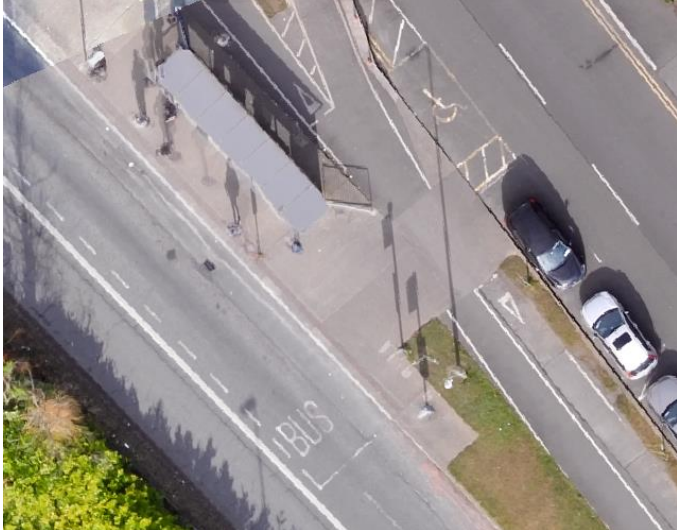
<p>Boosterstown Woodbine Road Bus Stop 2007: Missing tactile paving for pedestrians to cross cycle path. There is also no provision to indicate priority.</p>

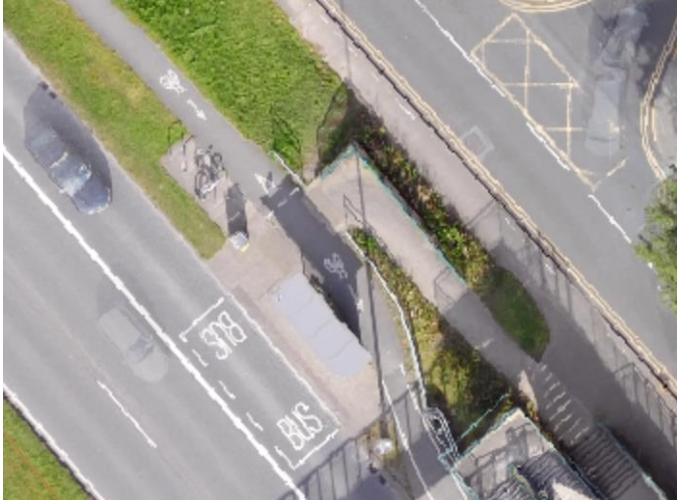
<p>Seafield Road Bus Stop 2008: Missing tactile paving for pedestrians to cross cycle path. There is also no provision to indicate priority.</p>

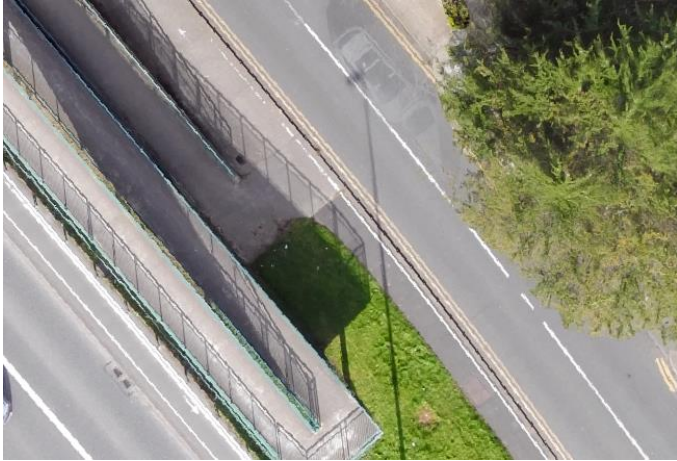
<p>Seafield Road Bus Stop 2008: Cycle path ends and becomes shared space with the lower section of the ramp to the overpass without warning.</p>

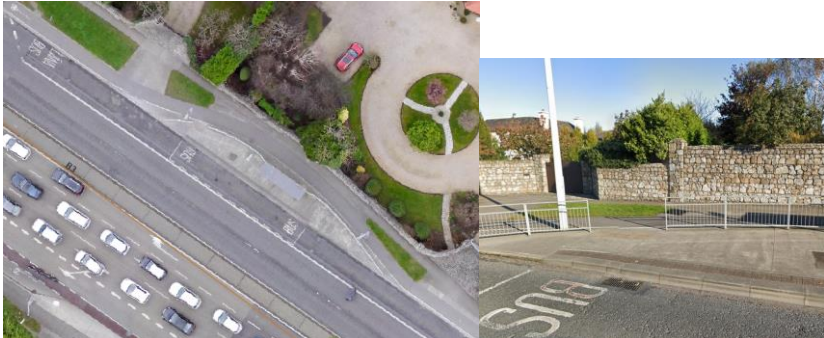
<p>Newtownpark Avenue Bus Stop 2016: Missing tactile paving for pedestrians to cross cycle path. Gap in fence does not align with the footpath. There is also no provision to indicate priority.</p>

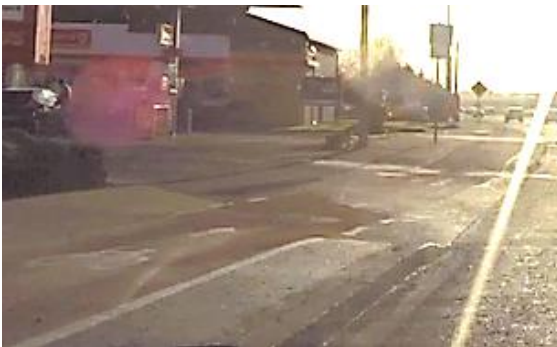
Figure 3.7: Example of kerb flush with road

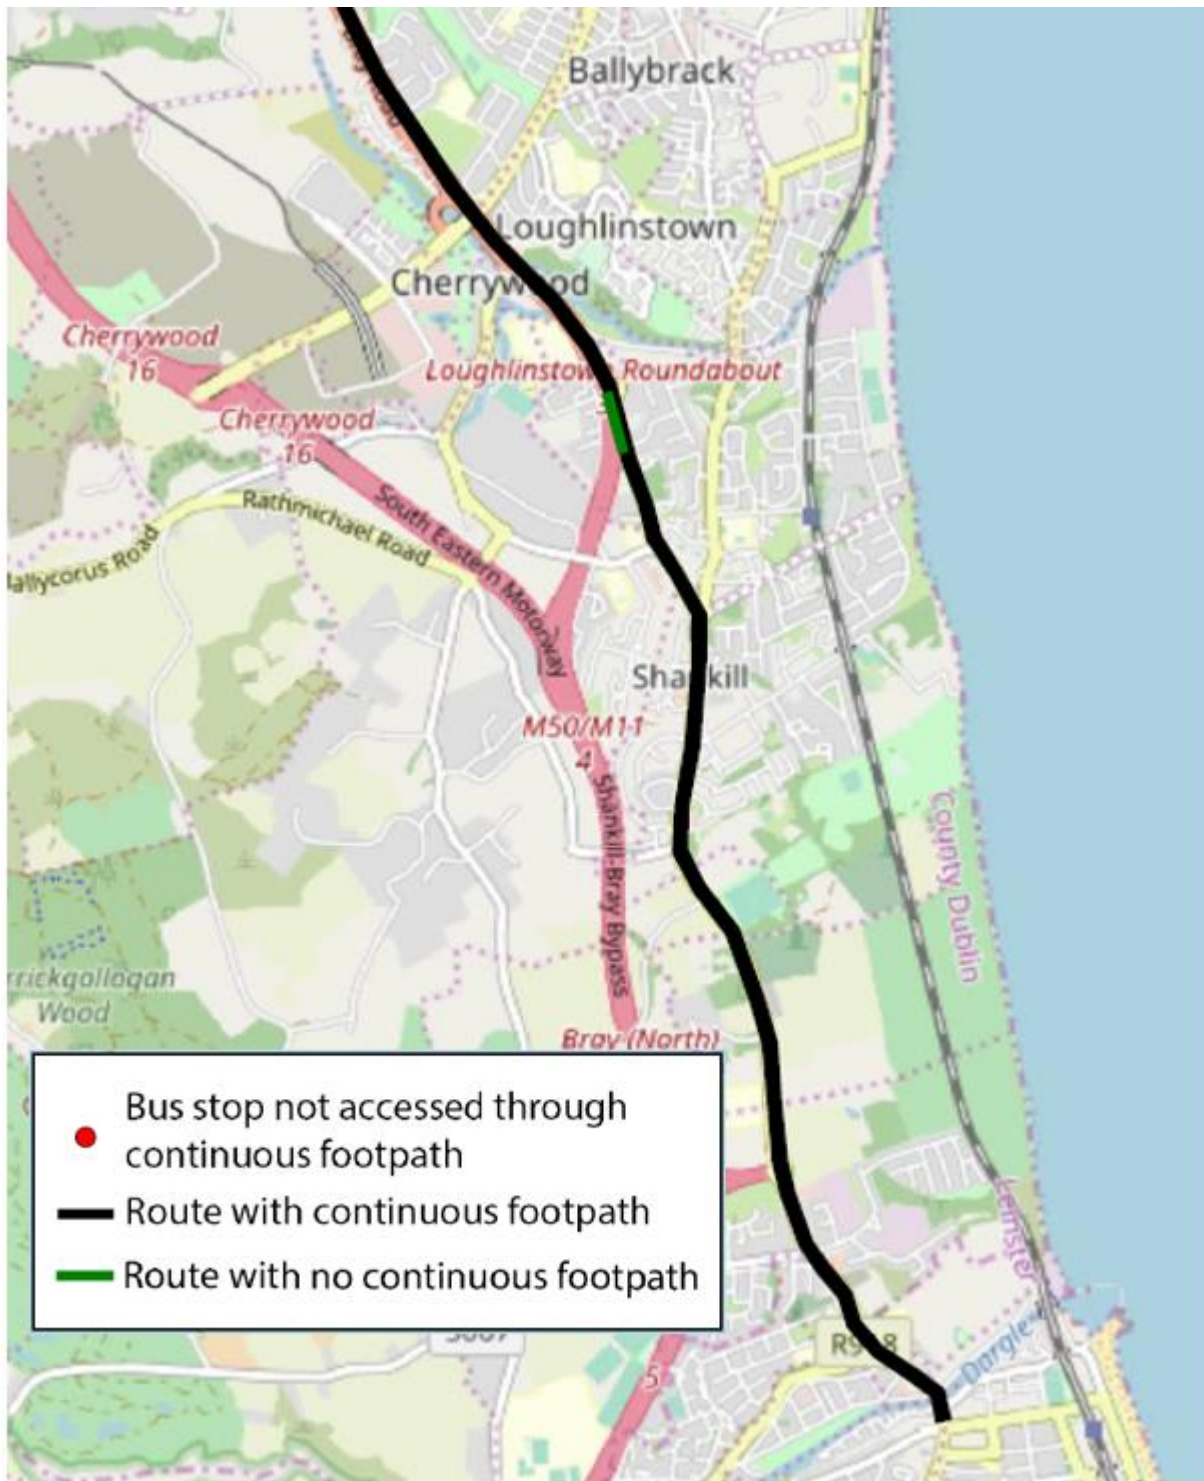
Figure 4.4 shows the section of the scheme within this section where there is no continuous footpath provided by design. These sections have either a crossing provided to the footpath on the other side or a footway on a parallel street away from the main road, with path access to the bus stops.

Figure 4.4: Sections of the scheme with no continuous footpath

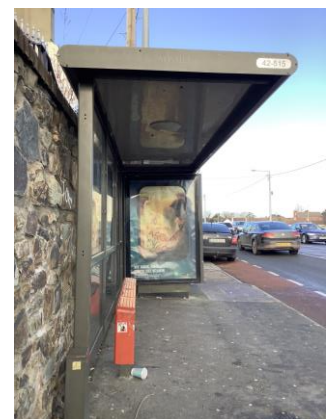
The footpath issues account for just over half of the issues identified in Section 4. Of these, there are 19 instances of broken or uneven footpath, six instances of broken kerbing, two instances of ponding and 26 inappropriately constructed vehicle crossover points. There are two sections where no footpath is provided at all, three sections of footpath are of insufficient width and there are three cases of inappropriate street furniture, such as the bus stop in Figure 5.4 which limits the footpath width to less than required.

Figure 5.4: Inappropriate bus stop
