Appendix M2
Road Safety Audit
- Stage 1

Jacobs Engineering Ireland Limited

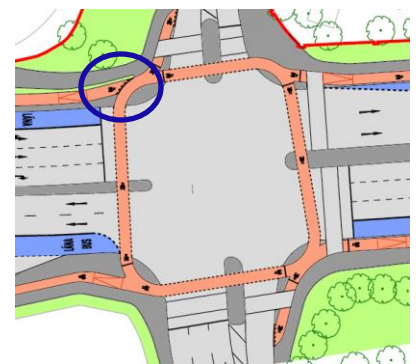
Figure 2.1 Priory Drive/ N11
Stillorgan Rd

It is noted that there are multiple pedestrian phases across the junctions in addition to multiple phases across individual arms on a junction. The Audit Team are unclear how the audio tactile push buttons will operate where poles are in close proximity. There is a risk of confusion for some pedestrians as a result.

The Design Team should ensure that all yield lines have associated yield symbols road markings implemented.

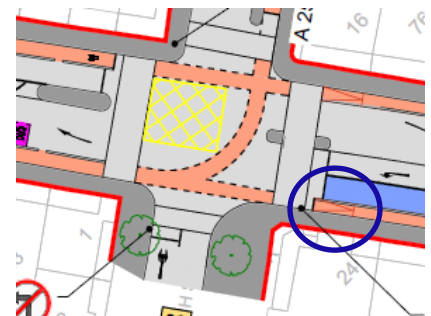
Figure 2.2 Pembroke St/ Leeson St Junction

The Audit Team notes that there is a narrowing of the cycle track in the vicinity of bus stops (e.g. Ch 8+800). There is concern these narrow sections of cycleway may cause cyclist to stray into adjacent footpath or passengers waiting areas putting pedestrians and cyclists in conflict with each other.

The Design Team should ensure a consistent approach to the location of the transition from cycle track to cycle lane on approaches to junctions, by setting the ramp back in accordance with the National Cycle Manual.

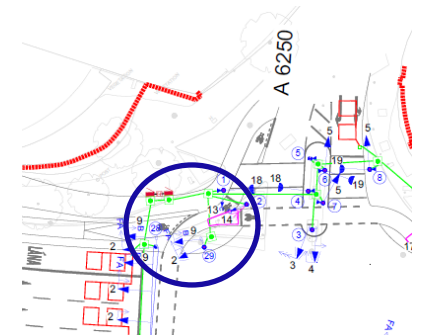
Figure 2.3 N11 Stillorgan Rd / Priory Dr / Old Dublin Rd

The drawings indicate the provision of a cycle lights in close proximity within the junction in various locations. There is concern that the alternative green phase of these lights will cause cyclists confusion putting them into conflict with either vehicular traffic or other vulnerable road users.

The Design Team should ensure cycle signals and associated stop lines are located in such a way not to cause confusion.

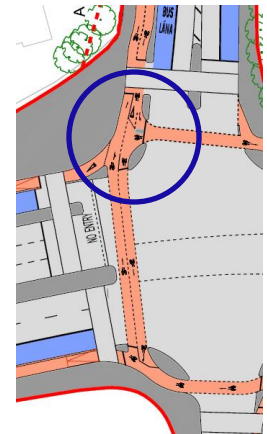
Figure 2.4 Greenfield Pk/ Nutley Lane/ Stillorgan Rd

The drawings identify cycle lanes with associated stop line markings in close proximity to each other. There is a concern that there may be insufficient cycle stacking room for cyclists waiting at some locations who will have a red light while the adjacent cycle lane may have green. This could cause frustration and lead to some cyclists either mounting the footpath or entering the carriageway, putting them into conflict with other road users.

The Design Team should ensure there is sufficient stacking room for future level of cyclists need.

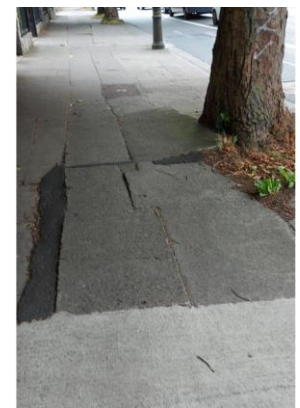
Significant cracking of pavements was observed onsite which makes navigation particularly difficult for mobility impaired pedestrians. It is unclear from the drawings provided how this issue will be addressed as part of the proposed scheme. The Audit Team is concerned there is an increased risk of damaged footway along the proposed scheme due to mature tree roots resulting in slipping and tripping hazards.

Figure 2.5 Trip Hazards along Leeson Street Upper due to impact of roots on mature trees

Where footways are being retained, the Design Team should ensure that damaged sections should be repaired as appropriate.

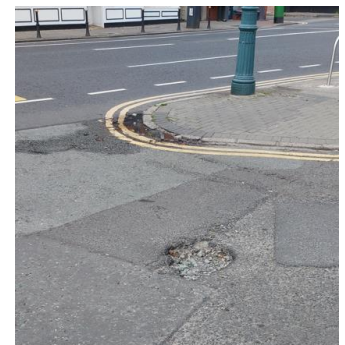
The Audit Team noted evidence of potential ponding of water in the carriageway at various locations. The widening of the carriageway to facilitate additional lanes may increase the risk of ponding of water increased the risk of loss of control type collision due to ice during cold conditions.

Figure 2.6 Evidence of ponding in the carriageway at Eglinton Terrace/ Donnybrook Rd junction

The Design Team should ensure the drainage design is sufficient to positively drain the carriageway and that gullies are provided upstream of pedestrian crossings.

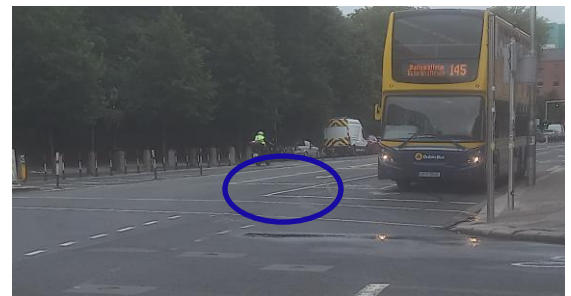
It was observed that the existing cycle lane is in the centre of the carriageway along St Stephens Green. The Audit Team is concerned that the cyclists may have to weave across a bus lane in conflicts with buses leading to an increased risk of collision.

Figure 3.1 Existing cycle Lane in middle of carriageway

The Design Team should review the layout and ensure appropriate tie-ins are utilised.

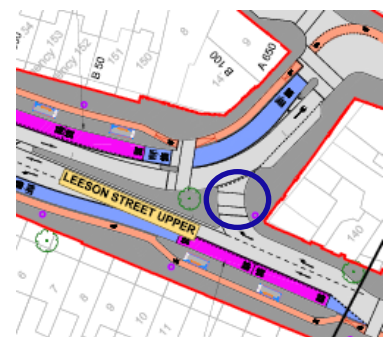
The Audit Team note that there are no "Triangular Yield Markings," provided. This may lead to an increased risk of motorists failing to understand the road layout ahead, leading to an increased risk of overshooting the junction.

Figure 3.3 Lack of a yield symbol

The Design Team should ensure suitable road markings are provided.

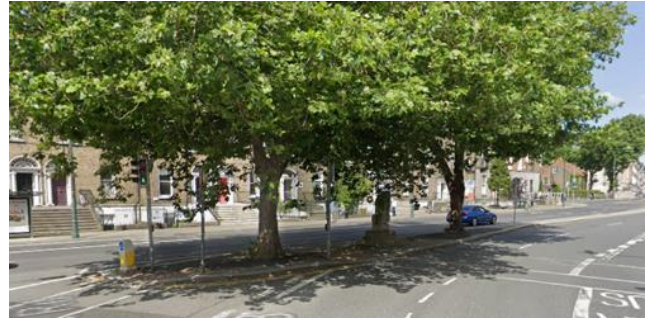
The Audit Team is concerned that the central island on Leeson Street Upper and Link road to Sussex Terrace, may not have adequate room to provide sufficient space for the foot path the presence of the large tree. This may lead to visible impaired users coming in conflict with the tree while trying to complete the crossing.

Figure 3.4 Existing Mature Tree along Leeson St Upper

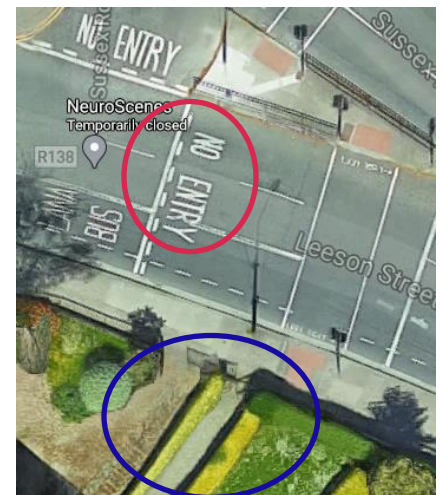
The Audit Team is concerned that the proposed ramps may hinder access to existing dwelling (Fig 3.2 Blue Circle) leading to an increased risk of loss of control type collisions.

Figure 3.5 Existing Access

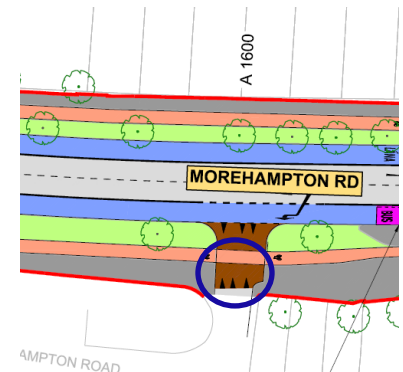
Figure 3.6 Proposed Table Ramp

The Design Team should ensure the tabletop ramp is sufficiently wide to cover the pedestrian desire lines.

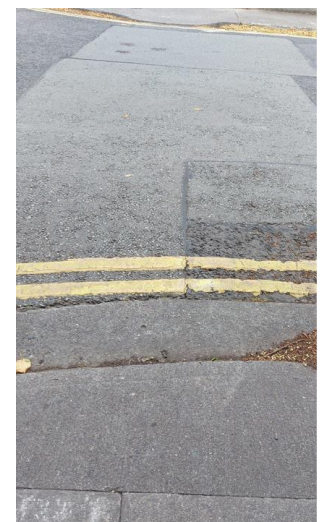
The Audit Team is concerned that the proposed cycle lane at chainage A2170 is of insufficient width and may lead to an increased risk of loss of control type collisions.

Figure 3.7 Existing In line crossing at Auburn Avenue Junction

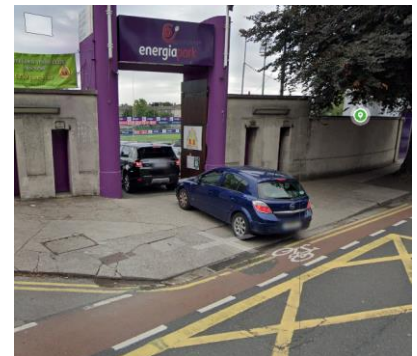
The Audit Team notes there is a vehicle access into Energia Park located at the proposed toucan crossing at Eglinton Terrace and Donnybrook Road which does not seem to be catered for in the design. There are concerns that this will lead to vehicle and Vulnerable Road Users conflicts.

Figure 3.8 Entrance to Energia Pk

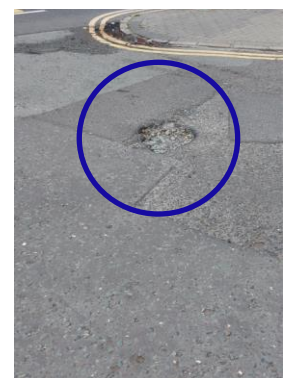
The Audit team noted deterioration of the pavement at the mouth of the Eglinton Terrace Junction with Donnybrook Road (Ch A2300) which could leave to ponding of water. This may lead to slips, trips and falls at the pedestrian crossing or loss of control during cold conditions.

Figure 3.9 Pothole at Junction Bellmouth

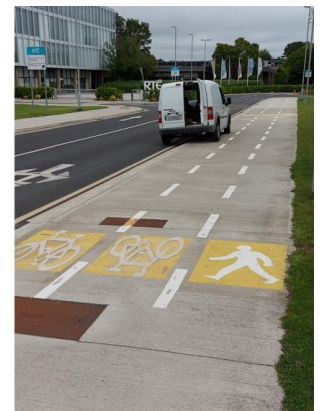
Figure 3.10 Existing off road cycle infrastructure at RTE access

The Design Team should review the tie in and ensure it is appropriate to tie into existing infrastructure.

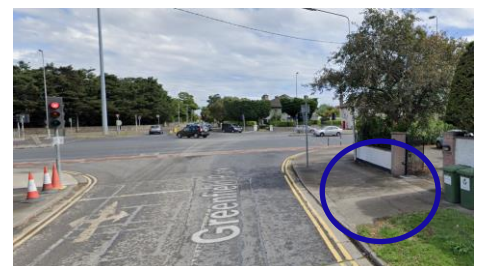
Figure 3.11 Existing Entrance (El Carmen)

The Design Team should ensure that the proposed crossing does not block access to the existing private access.

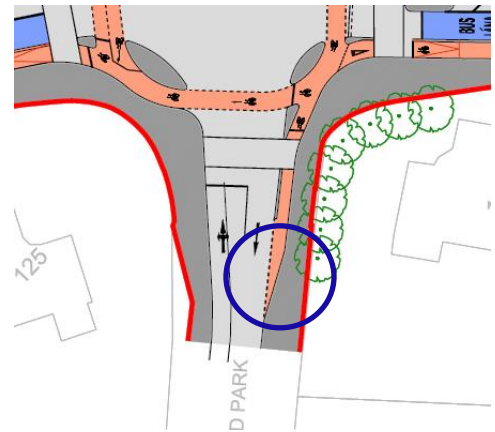
Figure 3.12 Missing Yield Road Markings

The Design Team should ensure that Yield road markings are provided to highlight road user priority.

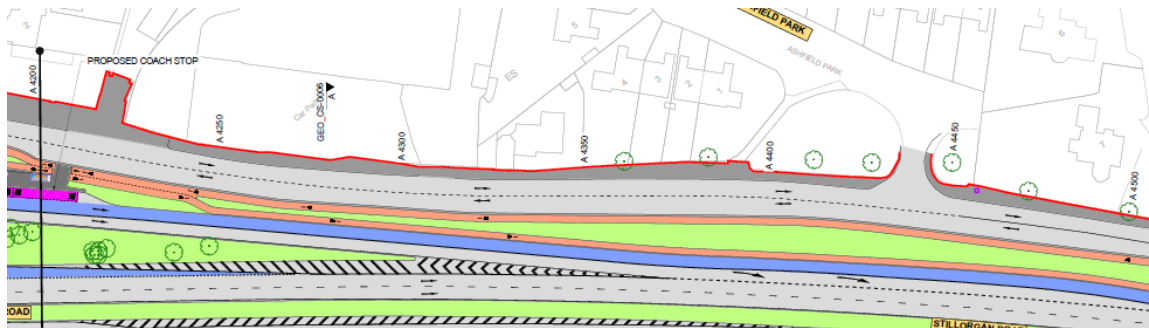
Figure 3.13 Local Link Road

The Audit Team are unclear if the existing parallel parking to the west side of the of the local link road is being retained or being removed. There is a concern that if this parking is removed and the cross section is not appropriately narrowed, this may lead to an increase in vehicle speeds and risk of collisions.

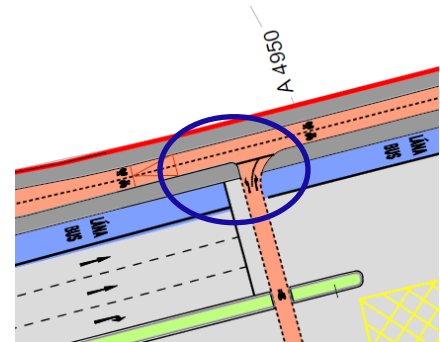
At chainage A4950, the Audit Team is concerned that cyclists may be forced to give way to cyclists travelling in a north south direction, leading to an increased risk of conflict with buses.

The Design Team should ensure that cyclists crossing the carriageway have priority over the cyclists on the two-way cycle lane.

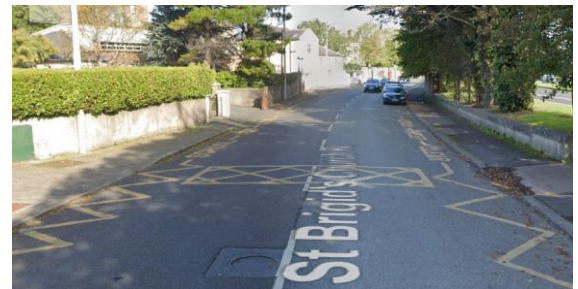
The Audit Team notes there are existing road markings due to St Brigid’s National School associated on Glenalbyn Rd. There are concerns that the removal of these markings may lead to increased speed putting the Vulnerable Road Users at an increased risk of conflict.

Figure 3.15 Road Markings outside St Brigid’s National School

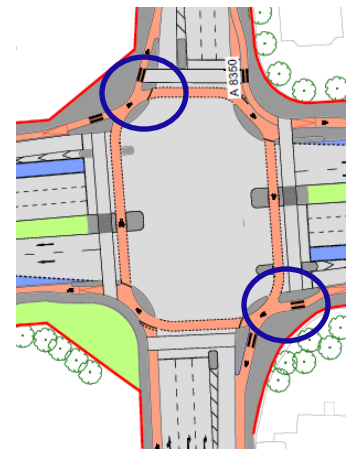
Figure 3.16 Inconsistent approach to pedestrian crossings

The Design Team should review this junction and provide a consistent approach with respect to pedestrian crossings on the carriageway and cycle track.

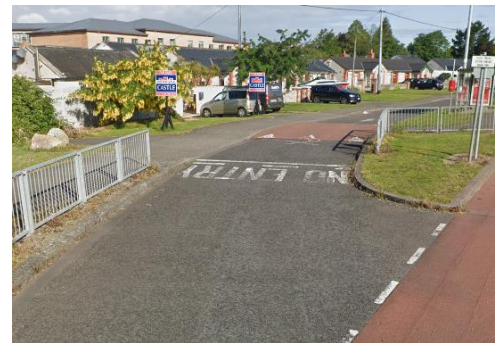
Figure 3.17 "No Entry" road markings

The Design Team should ensure there are appropriate marking in place to prevent unintended manoeuvres.

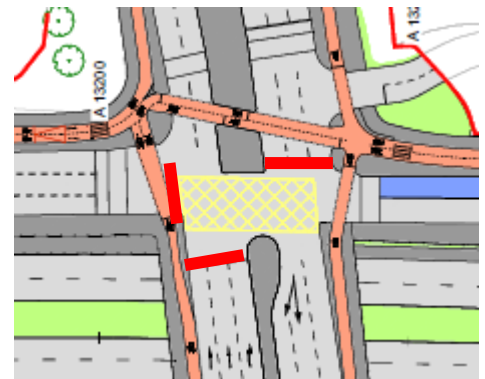
Figure 3.18 No Entry markings required

The Design Team should ensure there are appropriate marking in place to prevent unintended manoeuvres

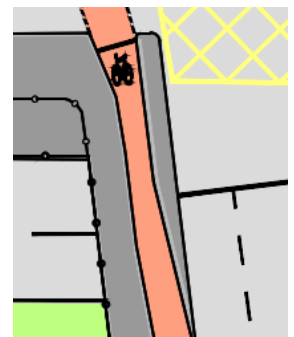
Figure 3.19 Cycle Lane narrows

The Design Team should ensure there is appropriate space for cyclists on approach to the junctions.

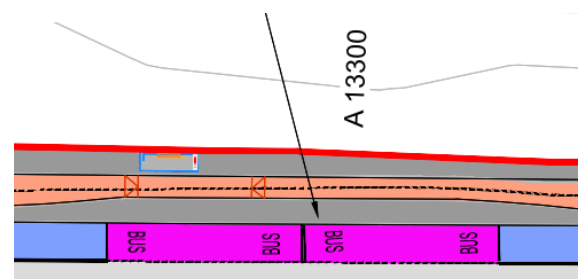
It is noted that there is a 2-way cycle track behind a double bus stop at chainage A13300 which narrows behind the proposed bus stopping area. The Audit Team is concerned that this may result in head on collisions between cyclists or an increased risk of conflict between pedestrians and cyclists.

Figure 3.20 Cycle Lane narrows

The Design Team should provide a cycle lane that is sufficiently wide to provide two-way flow.

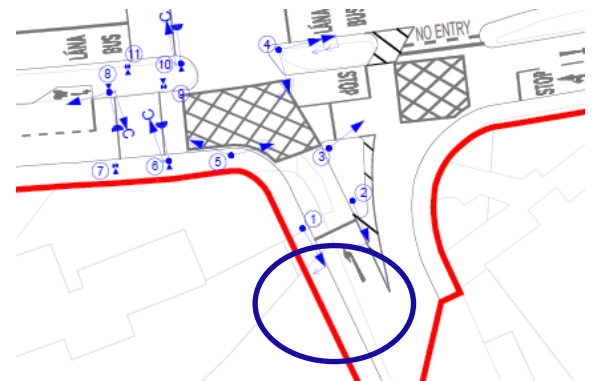
Figure 3.21 Lack of pedestrian facilities

The Design Team should ensure that pedestrian crossing facilities are provided.

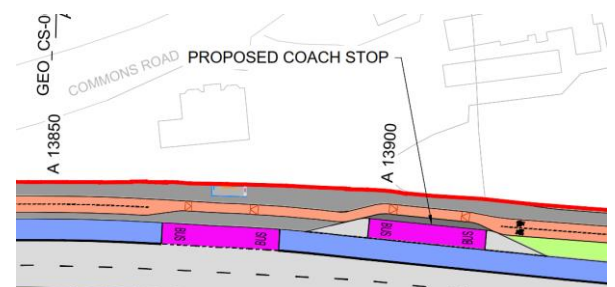
It is noted that there is a 2-way cycle track which becomes a 1-way track at chainage A13900. The Audit Team are concerned that this will result in an increased risk of cyclist confusion/ head on cyclist collisions or encroachment by cyclists onto the footpath in conflict with pedestrians.

Figure 3.22 Cycle Lane narrows

The Design Team should review the design to provide the 2-way cycle all along this route. Where this is not possible the distance of 1 way should be minimised to shortest possible length and appropriate warning put in place such as signage yield markings etc.

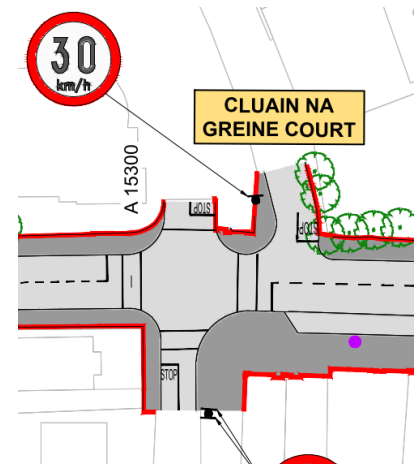
Figure 3.23 Cycle Lane narrows

The Design Team should provide a yellow box or integrated, vehicle activated signals to allow motorists to egress Cluain na Greine Court safely.

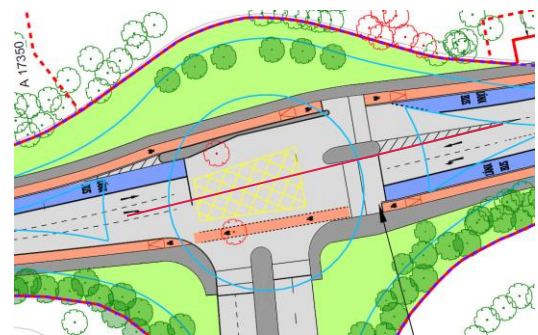
Figure 3.24 Risk of Head on Collisions

The design team should review the junction design to remove this risk using guidance lines and/or traffic islands.

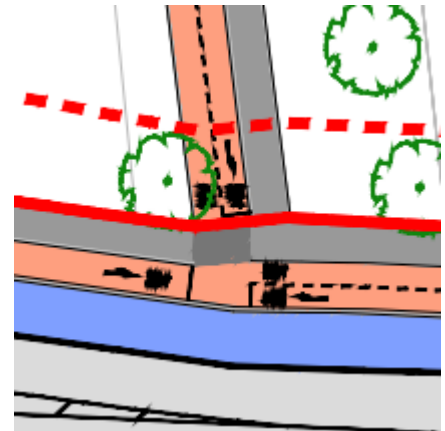
It is noted the proposed integration of new cycleway on the scheme with an existing offline cycle route at this location. The Audit Team are concerned about the potential for pedestrian and cyclist conflict at this location.

Figure 3.25 Cycle Lane Integration

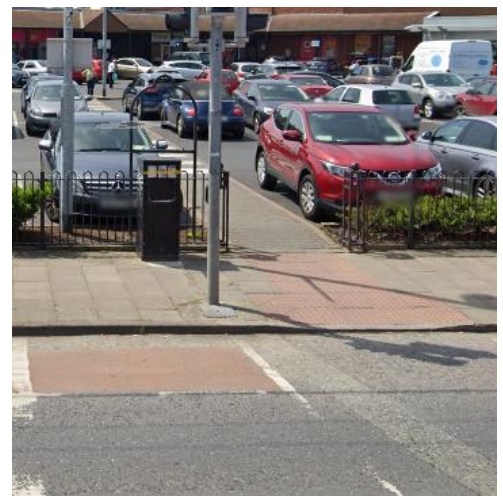
Figure 3.26 Footpath to shopping centre

The Design Team should consider relocating the pedestrian crossing back to the existing location.

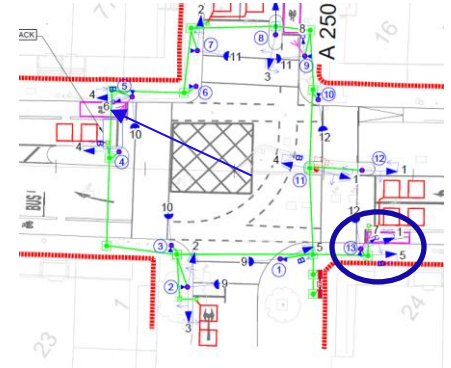
Figure 4.1 Secondary signal

The Design Team should consider relocating the secondary signal to the proposed traffic island opposite the stop line.

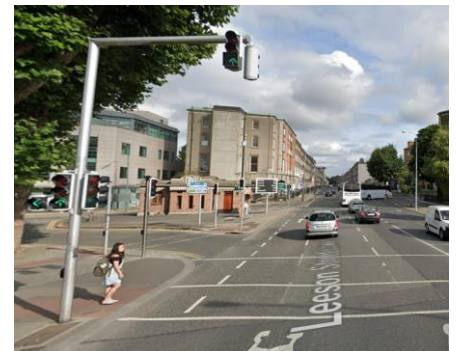
Figure 4.2 Cantilevered Signal Head on Leeson St Lower

The Design Team should provide a cantilever secondary signal head to match the current layout.

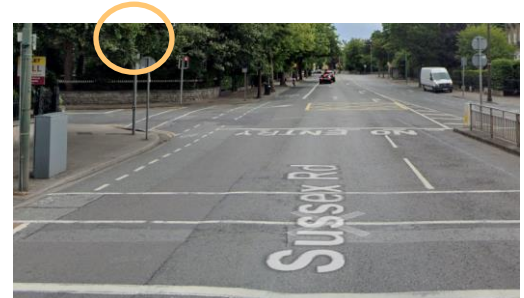
Along Sussex Rd eastbound at Chainage B400, the Audit Team note that existing vegetation may block visibility of the proposed secondary signal head (Signal Head 4). This may lead to an increase in driver confusion.

Figure 4.3 Visibility of signal head due to vegetation

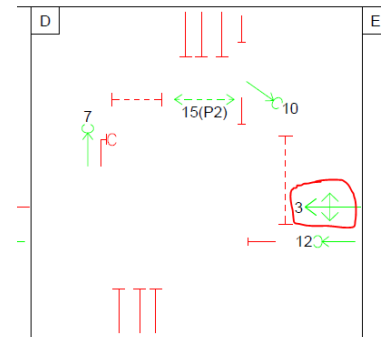
Figure 4.4 Incorrect stick diagram

The design team should ensure the stick diagram is correct.

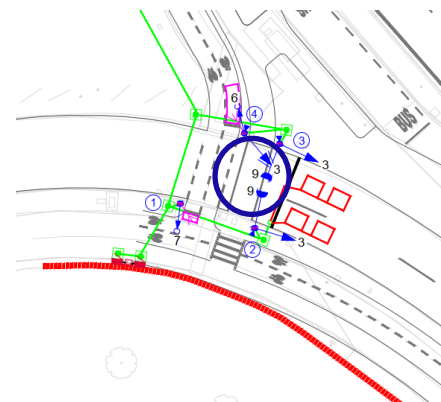
It is noted that there are adjacent pedestrian and cyclist crossings at A13050. The phasing arrangement at this location is such that these two modes will cross simultaneously however once passed the carriageway there is a pedestrian priority across the cycle track via zebra crossing road markings. The Audit Team are concerned that in the absence of formal signals, there is an increased risk of pedestrian/cyclist conflicts at this location.

Figure 4.5 Cycle & footway interaction

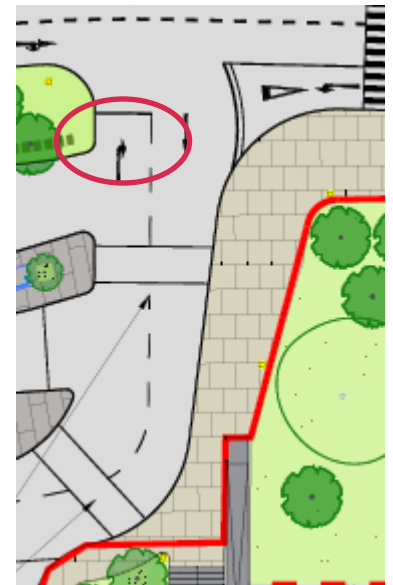
Figure 5.1 Lack of road markings directing buses

The Design Team should ensure that 'STOP' road markings are placed in appropriate location at the junction.

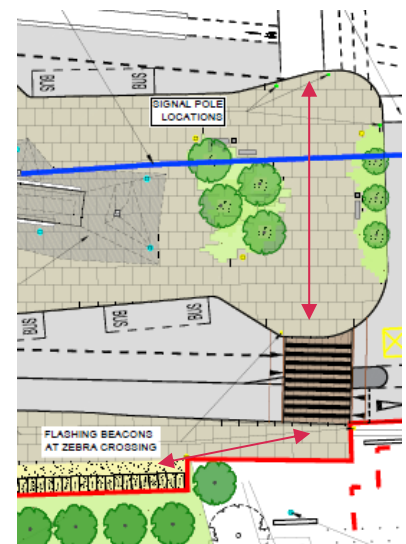
Figure 5.3 Cyclist desire line

The Design Team should consider measures to segregate pedestrians and cyclists or ensure this shared space encourages low speeds as part of an urban realm design and that the needs of the visually impaired are considered.

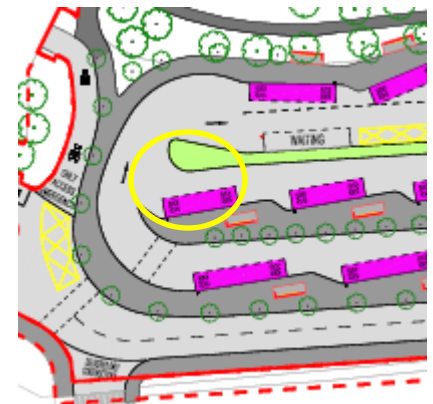
The Audit Team is concerned there is no Stop markings at the Northern side of the UCD Interchange (see Figure 6.1 No "STOP" road markings

Figure 6.1 No "STOP" road markings

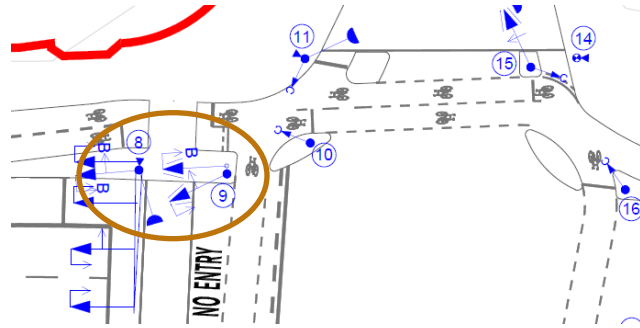
Figure 6.2 Risk of Pedestrian/ Cyclist conflicts

The design team should include signals to allow pedestrians cross the two-way cycle lane

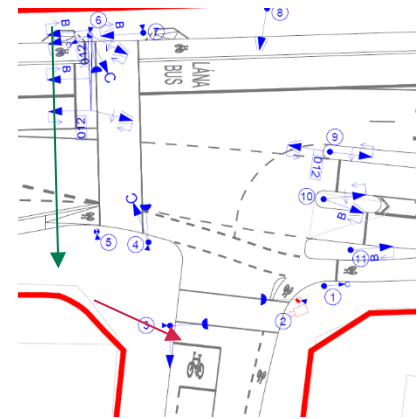
Figure 6.3 Facilities for cyclists

The design team should consider provision of a Toucan Crossing across Eglinton Rd.
