Bray to City Centre Core Bus Corridor Scheme June 2023

Preliminary Design Report

Appendix F Structures Reports

Appendix F7 St Annes Retaining Wall Record of Structural Review

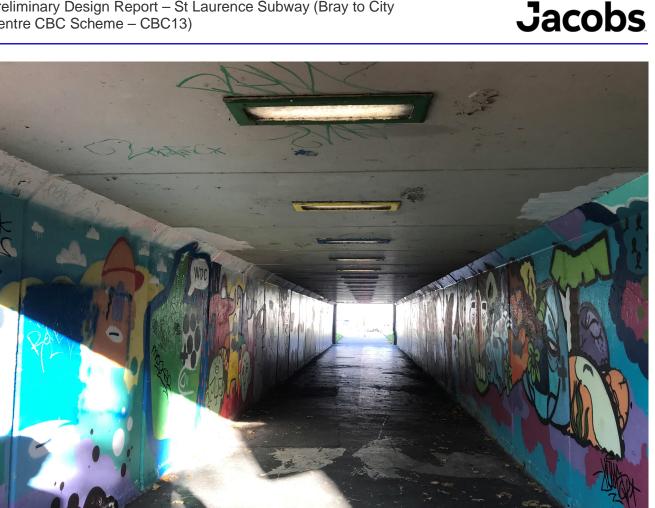
Figure 3.1: Interior of St Laurence Subway (November 2019)

This existing subway has artwork decorating the interior of the structure, see Figure 3.1. Numerous locations in the interior of the structure have been subjected to graffiti. Consideration should be given to painting the interior of the box in a colourful patterned finish or a piece of commissioned artwork to improve the appeal of use of the subway. These measures would aim to help decrease the risk of vandalism through graffiti. It should be noted that hydrophobic pore liners may impact the suitability of water-based paint systems.

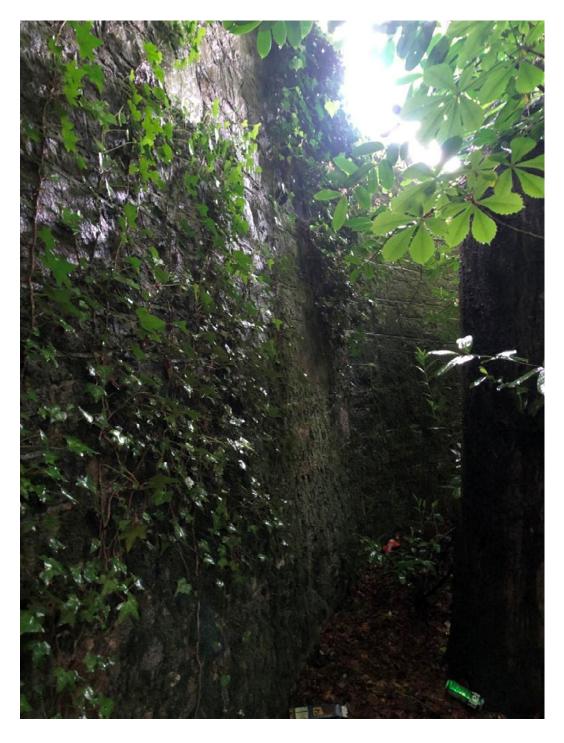
Figure 2 View of east elevation. Limited access

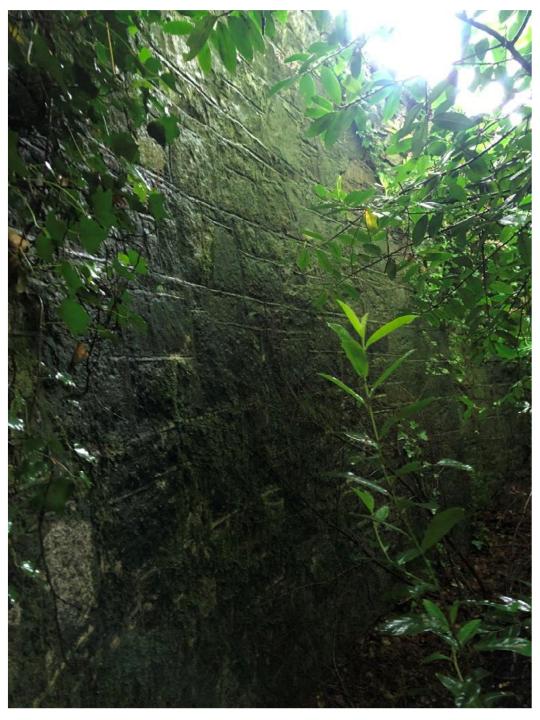
Figure 3 View of east elevation. Limited access

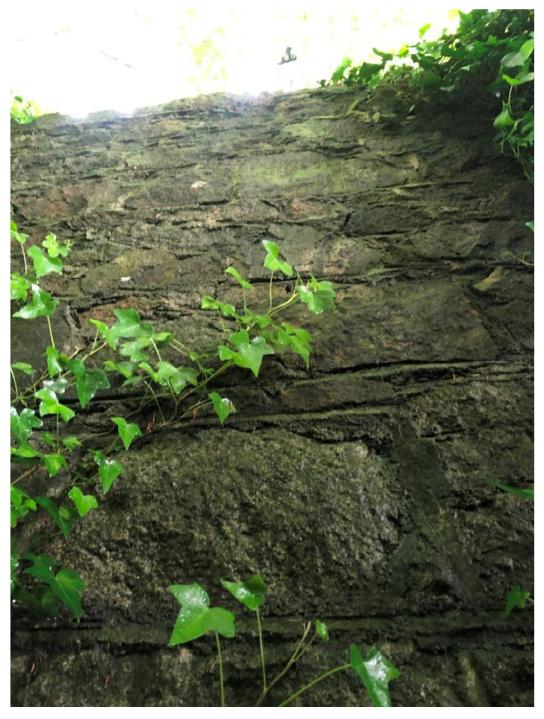
Figure 4 Typical condition of masonry on east elevation

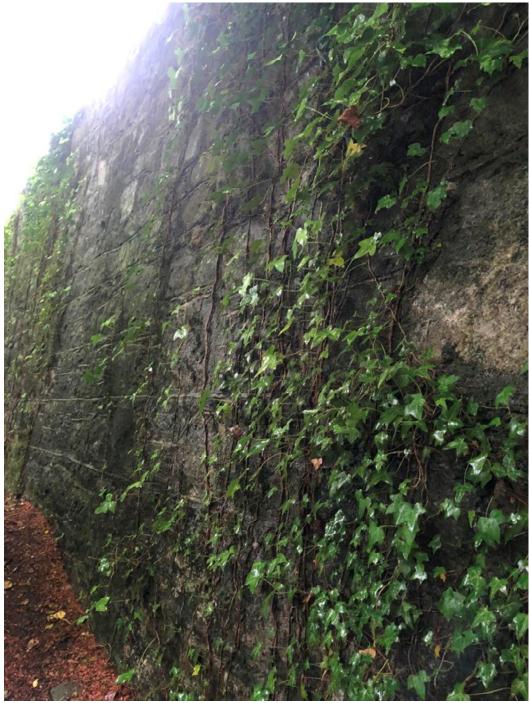
Figure 5 View of east elevation. Significant ingress of vegetation

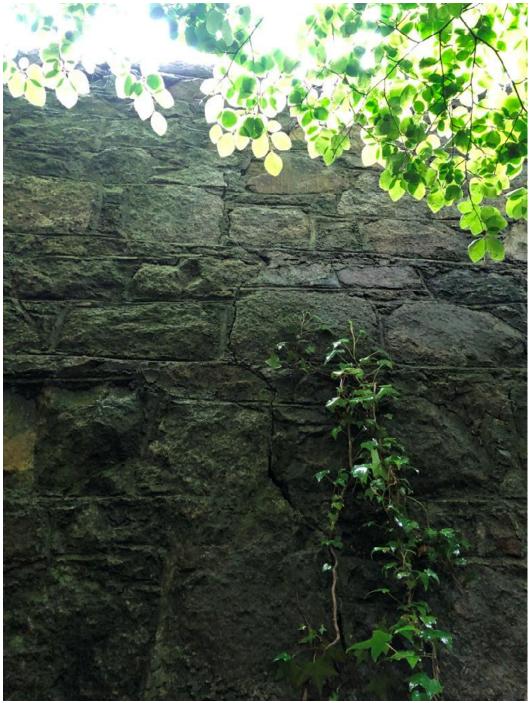
Figure 6 Vertical crack noted on east elevation

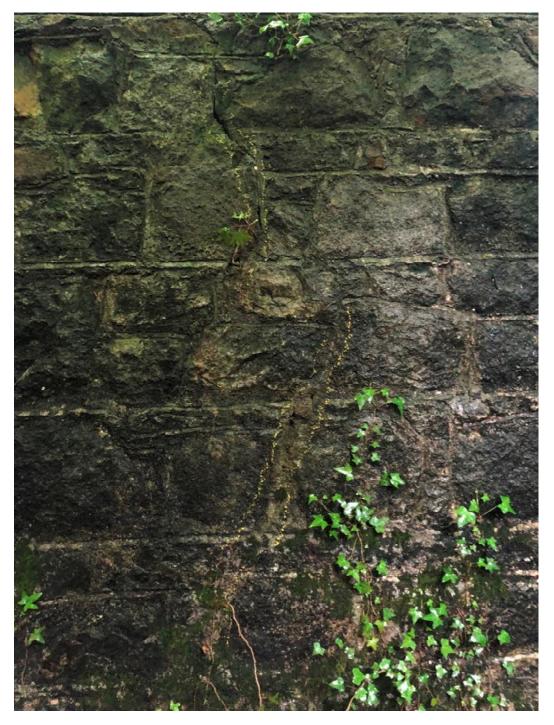
Figure 7 Vertical crack noted on east elevation

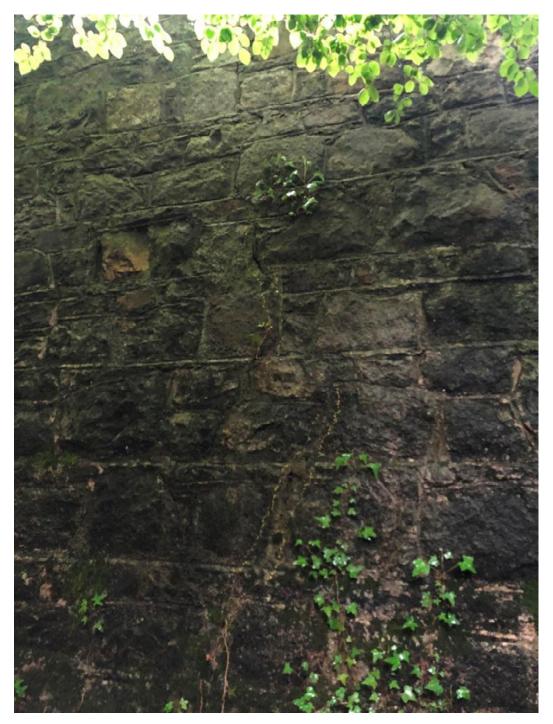
Figure 8 Vertical crack noted on east elevation

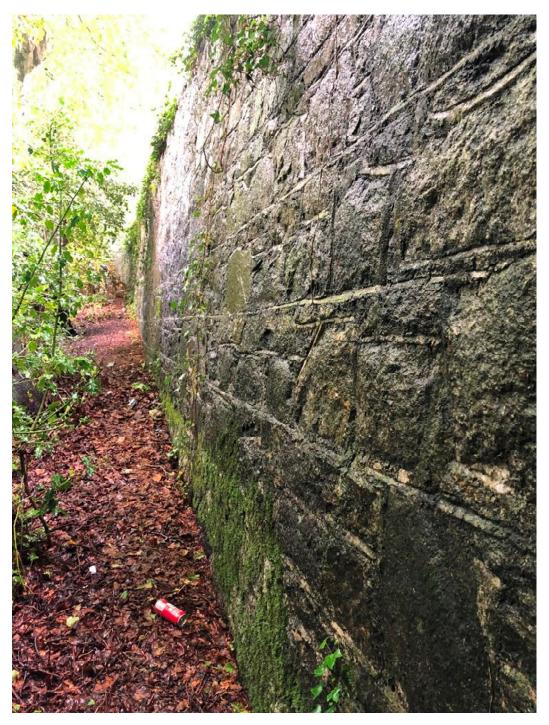
Figure 9 Algae growth noted at base of east wall.

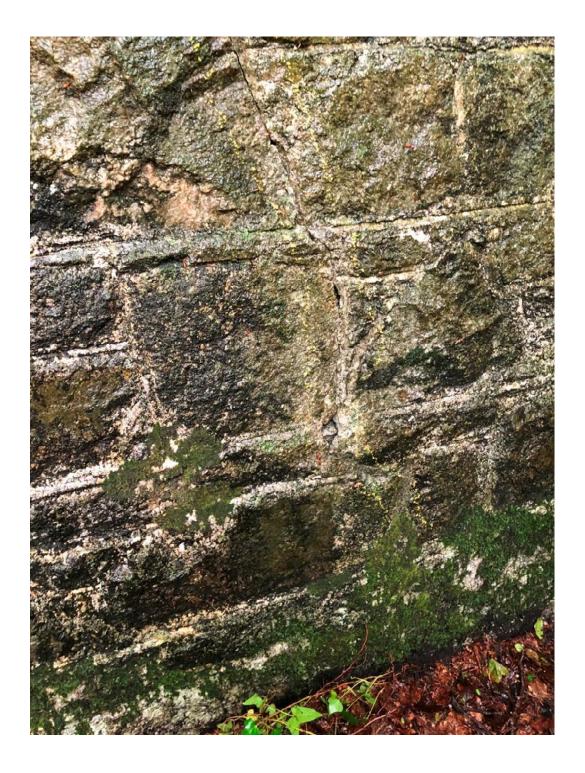
Figure 10 Vertical crack noted on east elevation

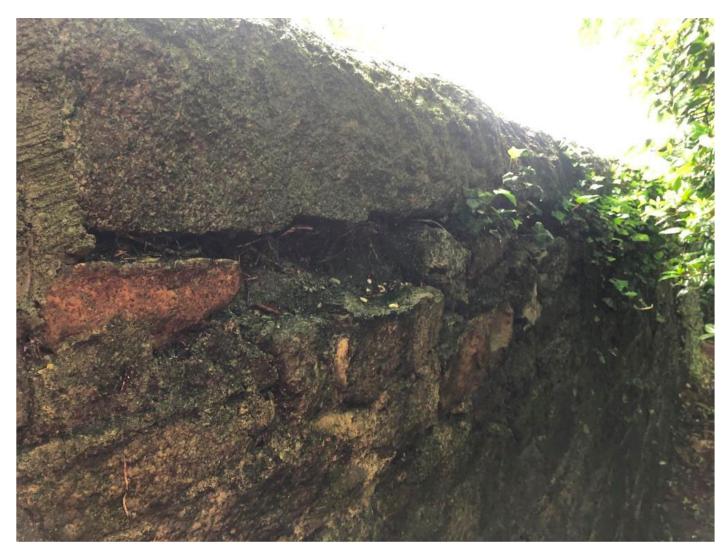
Figure 11, Missing blockwork noted at top of east wall

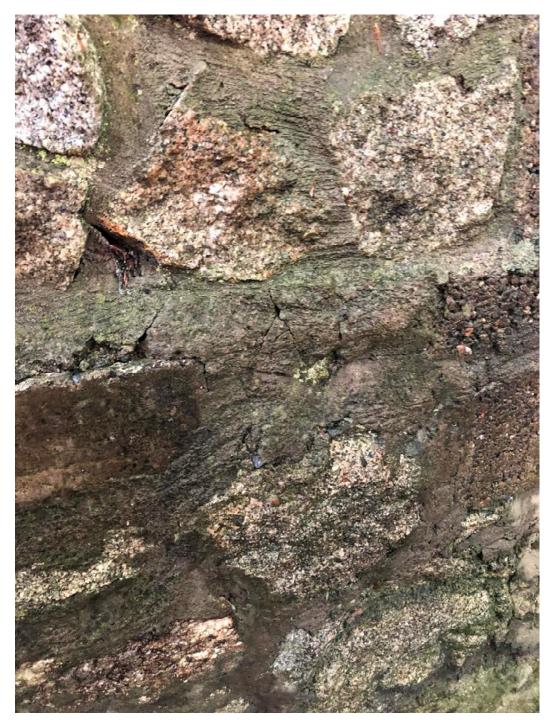
Figure 12 Hairline cracks noted at multiple locations

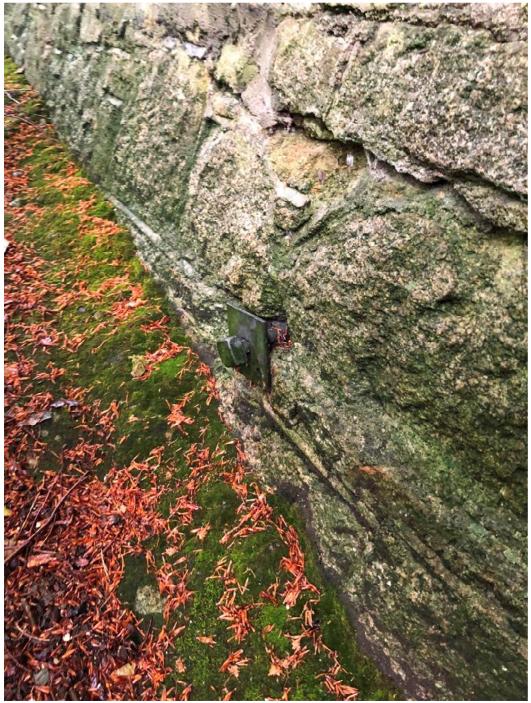
Figure 13 Exposed tie bar noted on east elevation

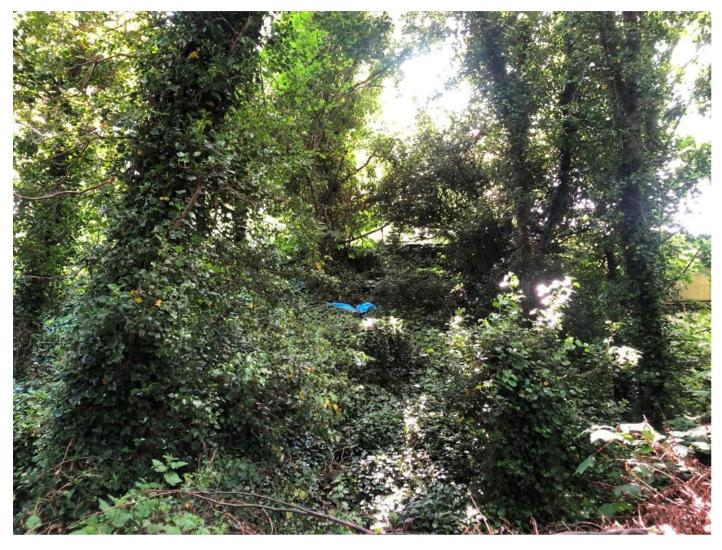
Figure 15 Extensive vegetation growth obscuring parts of the west elevation

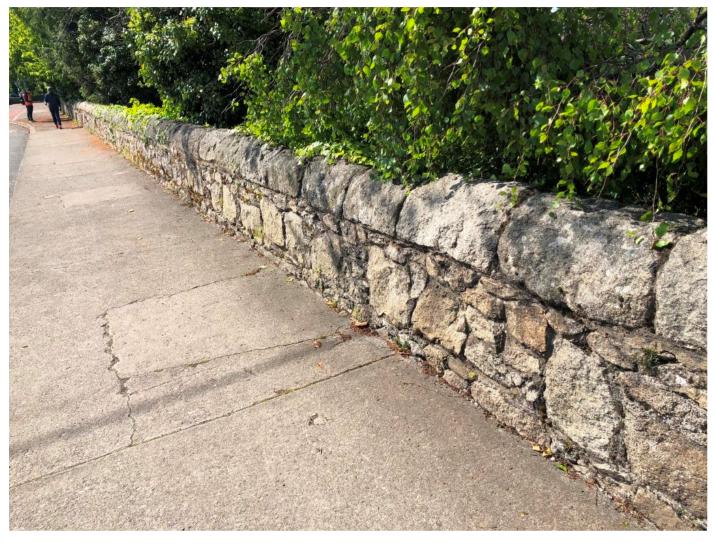
Figure 16 North west parapet in generally good condition.

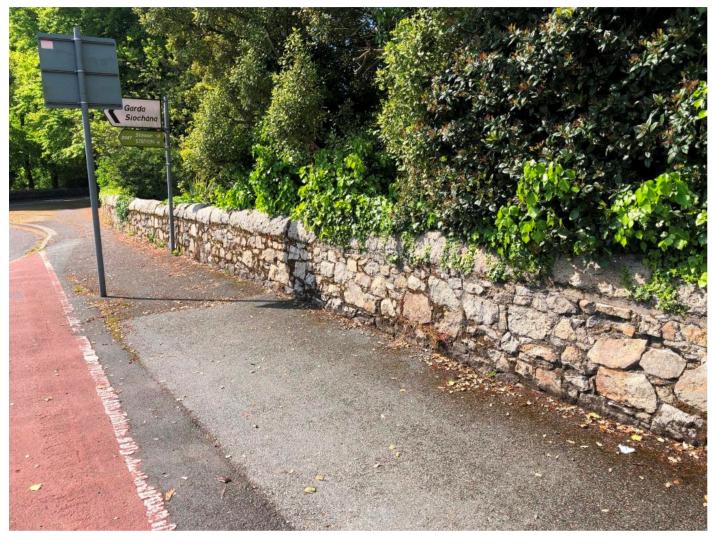
Figure 17 Some loss of mortar on west parapet

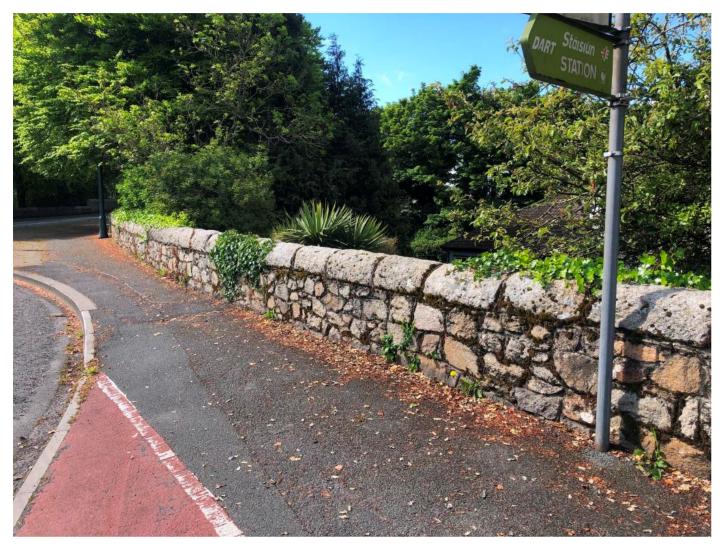
Figure 18 Areas of mortar loss and algae growth on the west parapet. General wear noted on footway surfacing

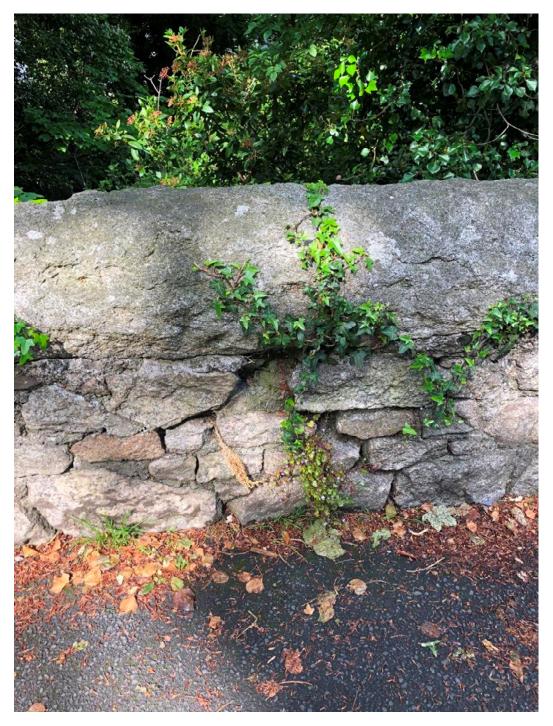
Figure 19 Missing blockwork noted on south west parapet

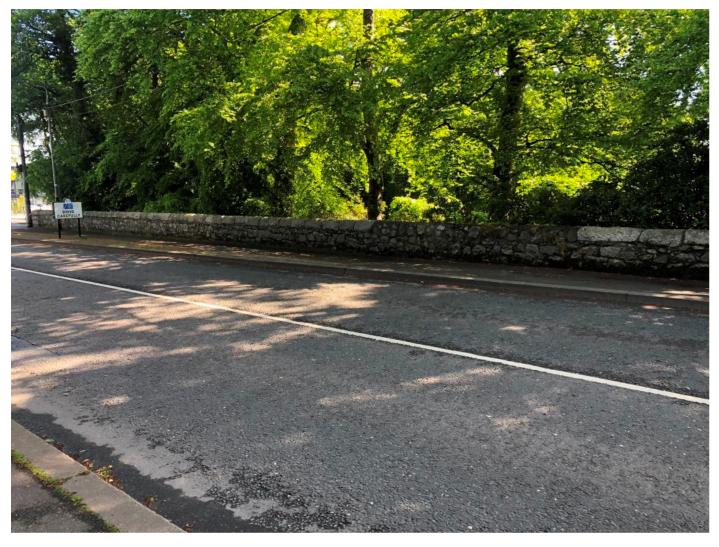
Figure 20 East parapet in generally good condition. Areas of mortar loss and Algae growth noted.

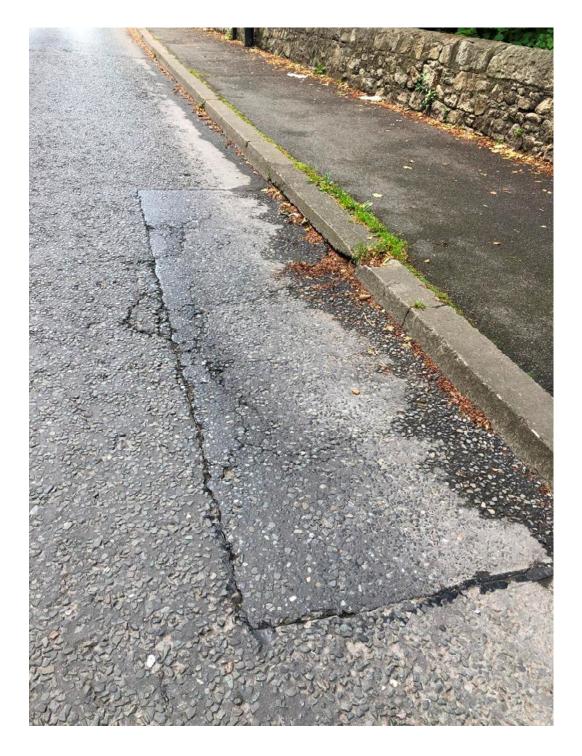
Figure 21 Damage to west kerb and carriageway noted
