Appendix I1
Accessibility
Audit Report

Jacobs Engineering Ireland Limited

As a part of the Engineering Design Services for the Preliminary Design and Planning Stage, through to the end of the Statutory Process of the BusConnects Radial Core Bus Corridors Infrastructure Programme, an audit of the existing infrastructure provided for people with disabilities along the proposed Bray to City Centre Core Bus Corridor (CBC) has been carried out. This report outlines the standards and guidelines that should be used to provide suitable infrastructure for people with disabilities, the process and outcomes of the audit and recommended improvements that will bring the existing infrastructure up to standard.

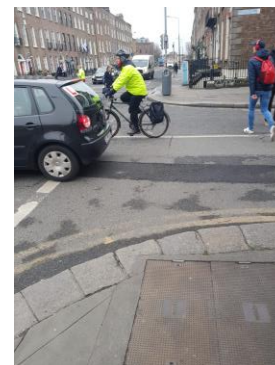
Figure 2.5: No crossing facilities

There are 106 issues that are due to crossings. There are six crossings where no facilities are provided (such as Figure 2.5), 33 crossings where there is no tactile paving provided, two with no dropped kerb, 42 crossings with incorrect tactile paving and five crossings with dropped kerbs that aren't flush with the crossing. There are five crossings that are not aligned and one instance where a continuous cycle track is indicated at a signalized pedestrian crossing. There are three push buttons incorrectly positioned and eight crossings with poor road surfacing. There is also one crossing that is wider than it should be given the green walk time allowed and with no refuge provided.

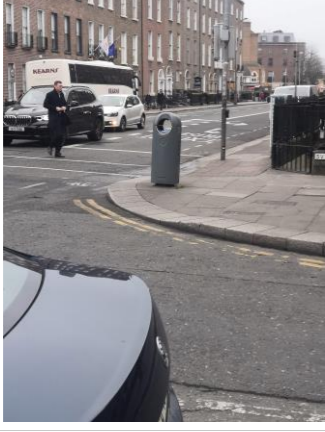
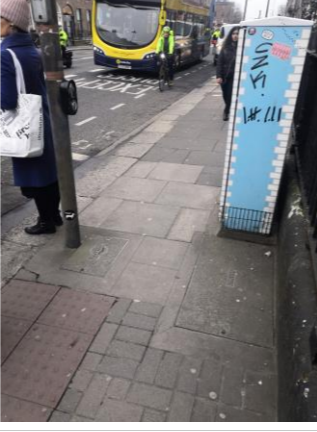
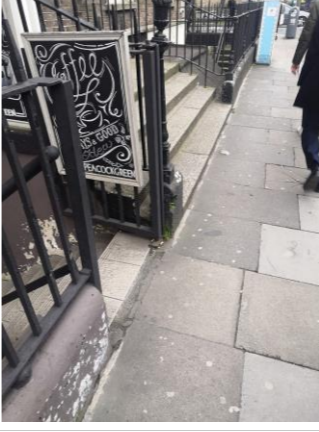
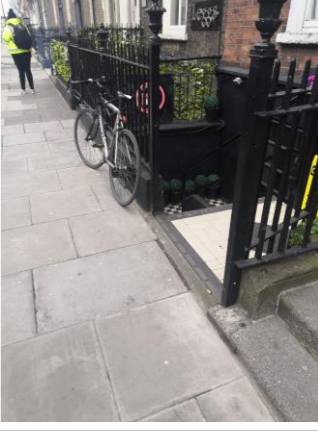
8 - Unsuitable access for disabled users	17 - No tactile paving at crossing	18 - No dropped kerbs at crossing	25 - Unsuitable access for disabled users
<p>This is located on Leeson Street Lower outside buildings 1, 2 & 3. It is considered high severity as there is a large and sustained trip hazard.</p>	<p>This is located on Leeson Street Lower. It is considered high severity as a lack of tactile paving makes visually impaired pedestrians unaware of the presence of the crossing.</p>	<p>This is located on Leeson Street Lower. It is considered high severity as a lack of tactile paving makes visually impaired pedestrians unaware of the presence of the crossing and can also introduce a trip hazard.</p>	<p>This is located on Leeson Street Lower. It is considered high severity as there is a below-ground building entrance with no hazard warning for visually impaired pedestrians.</p>

<p>716185, 732991</p>	<p>716204, 732976</p>	<p>716210, 732967</p>	<p>716221, 732954</p>
<p>Solution: Provide tactile paving at this crossing.</p>	<p>Solution: Reposition street furniture to allow sufficient space for wheelchair users.</p>	<p>Solution: Either provide tactile paving or a level difference so that disabled users can determine the edge of the path.</p>	<p>Solution: Either provide tactile paving or a level difference so that disabled users can determine the edge of the path.</p>

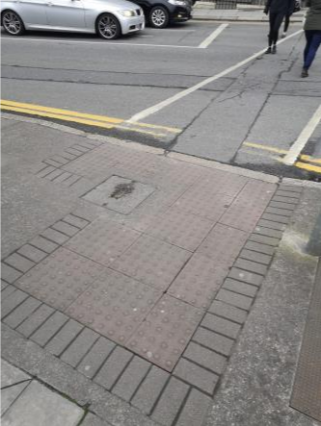
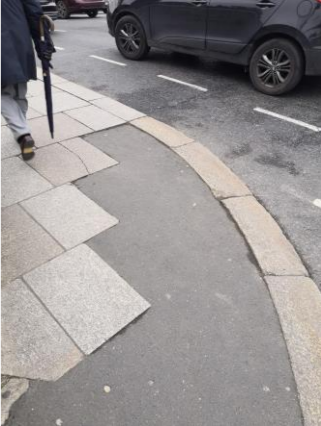
42 - Unsuitable access for disabled users	50 - Incorrect tactile paving at crossing	54 - Unsuitable access for disabled users	55 - Broken paving / footway
<p>This is located on Leeson Street Lower north of the junction with Adelaide Road. It is considered high severity as there is a below-ground building entrance with no hazard warning for visually impaired pedestrians.</p>	<p>This is located on Leeson Street Lower at the junction with Adelaide Road. It is considered high severity as incorrect tactile paving makes visually impaired pedestrians unaware of the type of crossing and could lead to dangerous crossing movements.</p>	<p>This is located on Leeson Street Lower at the junction with Adelaide Road. It is considered high severity due to the risk of collision between pedestrians and cyclists.</p>	<p>This is located on Leeson Street Lower at the junction with Mespil Road. It is considered high severity due to the presence of a trip hazard which could result in a dangerous fall into the carriageway.</p>

<p>716297, 732840</p>	<p>716337, 732788</p>	<p>716362, 732750</p>	<p>716375, 732725</p>
<p>Solution: Either provide tactile paving or a level difference so that disabled users can determine the edge of the path.</p>	<p>Solution: Upgrade tactile paving to match the current standards.</p>	<p>Solution: Provide clear markers for interactions between all users in this shared space, particularly between pedestrians and cyclists.</p>	<p>Solution: Repair paving to be even and suitable for disabled users.</p>
61 - No tactile paving at crossing	63 - No tactile paving at crossing	67 - Inappropriately constructed vehicle crossover point (multiple along stretch of road)	69 - Inappropriately constructed vehicle crossover point (multiple along stretch of road)
<p>This is located on Leeson Street Upper at the junction with Darthmouth Road. It is considered high severity as a lack of tactile paving makes visually impaired pedestrians unaware of the presence of the crossing.</p>	<p>This is located on Leeson Street Upper at the junction with Darthmouth Road. It is considered high severity as a lack of tactile paving makes visually impaired pedestrians unaware of the presence of the crossing.</p>	<p>These are located on Leeson Street Upper. They are considered high severity due to the risk of visually impaired pedestrians not being aware of the presence of a kerb and veering into the carriageway.</p>	<p>These are located on Leeson Street Upper. They are considered high severity due to the risk of visually impaired pedestrians not being aware of the presence of a kerb and veering into the carriageway.</p>

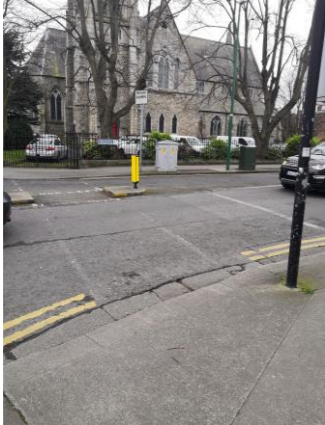
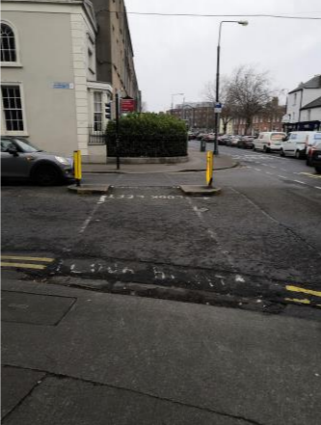
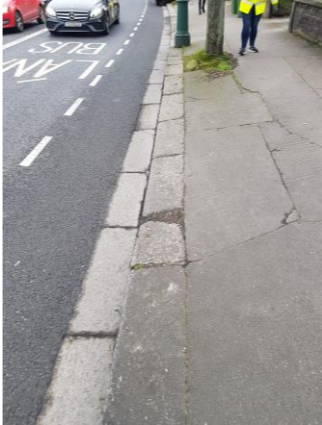
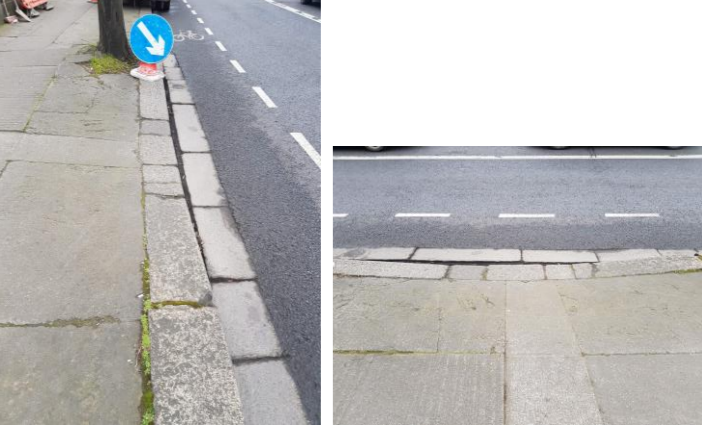
<p>72 - Inappropriately constructed vehicle crossover point (multiple along stretch of road)</p>	<p>73 - Inappropriately constructed vehicle crossover point (multiple along stretch of road)</p>	<p>74 - Broken paving / footway</p>	<p>75 - Broken paving / footway</p>
<p>These are located on Leeson Street Upper. They are considered high severity due to the risk of visually impaired pedestrians not being aware of the presence of a kerb and veering into the carriageway.</p>	<p>These are located on Leeson Street Upper. They are considered high severity due to the risk of visually impaired pedestrians not being aware of the presence of a kerb and veering into the carriageway.</p>	<p>This is located on Leeson Street Upper. It is considered high severity due to the presence of a trip hazard which could result in a dangerous fall into the carriageway.</p>	<p>This is located on Leeson Street Upper. It is considered high severity due to the presence of a trip hazard which could result in a dangerous fall into the carriageway.</p>

<p>716425, 732591</p>	<p>716433, 732584</p>	<p>716485, 732517</p>	<p>716509, 732479</p>
<p>Solution: Provide required tactile paving.</p>	<p>Solution: Provide required tactile paving.</p>	<p>Solution: Reconstruct the vehicle crossings to match the level difference required in the current standards.</p>	<p>Solution: Reconstruct the vehicle crossings to match the level difference required in the current standards.</p>

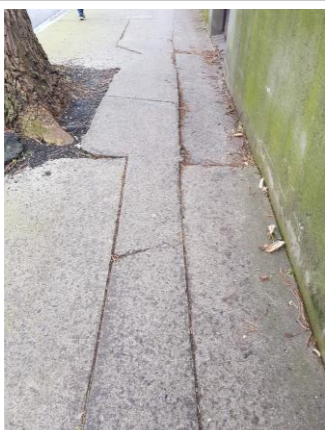
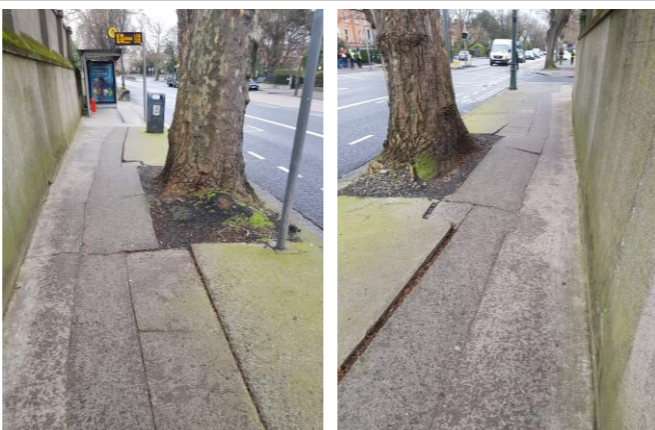
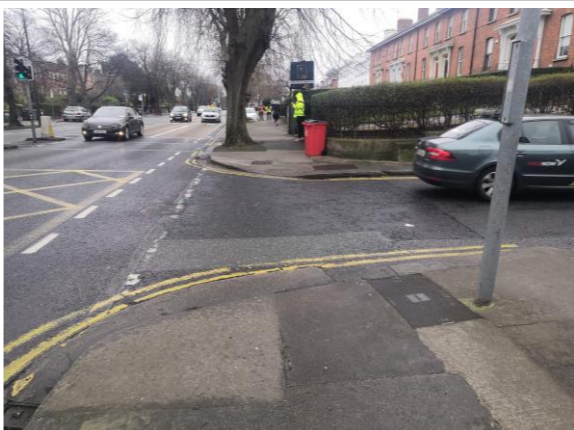
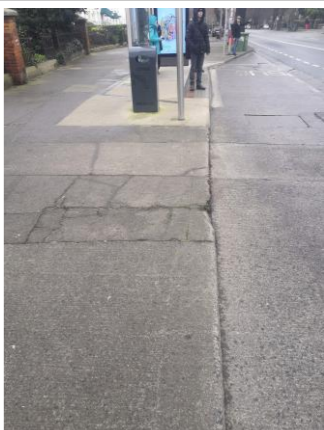
<p>Solution: Repair paving to be even and suitable for disabled users.</p>	<p>Solution: Repair paving to be even and suitable for disabled users.</p>	<p>Solution: Repair paving to be even and suitable for disabled users.</p>	<p>Solution: Provide crossing facilities at this location.</p>
<p>103 - Broken paving / footway</p>	<p>105 - Broken paving / footway</p>	<p>106 - No tactile paving at crossing</p>	<p>120 - Broken paving / footway</p>
<p>This is located on Morehampton Road. It is considered high severity due to the presence of a trip hazard which could result in a dangerous fall.</p>	<p>This is located on Morehampton Road. It is considered high severity due to the presence of a trip hazard which could result in a dangerous fall.</p>	<p>This is located on Morehampton Road at the junction with Bloomfield Avenue. It is considered high severity as a lack of tactile paving makes visually impaired pedestrians unaware of the presence of the crossing.</p>	<p>This is located on Morehampton Road. It is considered high severity due to the presence of a trip hazard which could result in a dangerous fall into the carriageway.</p>

<p>716967, 732225</p>	<p>716987, 732196</p>	<p>717011, 732165</p>	<p>717138, 732022</p>
<p>Solution: Repair paving to be even and suitable for disabled users.</p>	<p>Solution: Repair paving to be even and suitable for disabled users.</p>	<p>Solution: Provide tactile paving at this crossing.</p>	<p>Solution: Repair paving to be even and suitable for disabled users.</p>

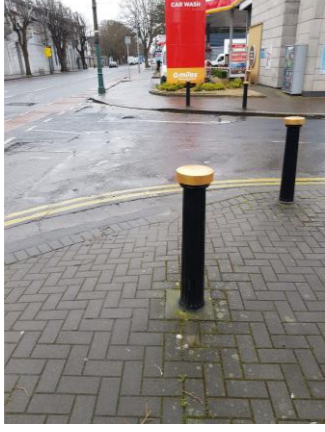
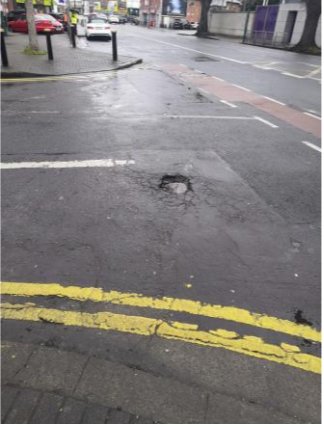
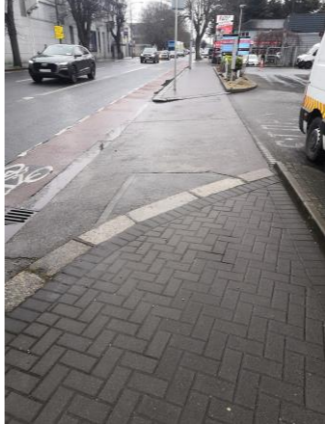
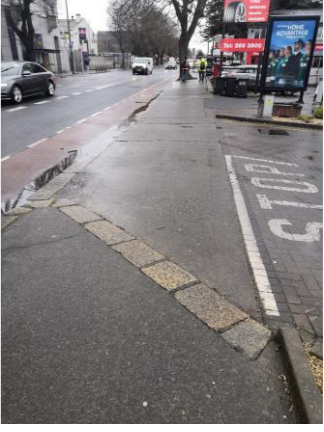
<p>717575, 731586</p>	<p>717577, 731585</p>	<p>717609, 731545</p>	<p>717634, 731517</p>
<p>Solution: Provide tactile paving at this crossing.</p>	<p>Solution: Reconstruct crossing to align dropped kerbs.</p>	<p>Solution: Reposition street furniture to allow sufficient space for wheelchair users.</p>	<p>Solution: Provide tactile paving at this crossing.</p>
<p>174 - Inappropriate street furniture</p>	<p>175 - Road Surfacing at Crossing Poor</p>	<p>177 - No tactile paving at crossing</p>	<p>178 - No crossing facilities provided</p>
<p>This is located on Donnybrook Road opposite Energia Park. It is considered high severity due to the obstruction of the footway in a manner that would not be anticipated by visually impaired pedestrians.</p>	<p>This is located on Donnybrook Road crossing Brookvale Road. It is considered high severity due to the presence of a trip hazard on the road surface which could result in a fall in a dangerous location.</p>	<p>This is located on Donnybrook Road opposite Energia Park. It is considered high severity as a lack of tactile paving makes visually impaired pedestrians unaware of the presence of the crossing.</p>	<p>This is located on Donnybrook Road opposite Energia Park. It is considered high severity as there are no alternatives to crossing at this point and it makes crossing inaccessible.</p>

<p>717633, 731518</p>	<p>717636, 731517</p>	<p>717640, 731510</p>	<p>717664, 731481</p>
<p>Solution: Investigate the need for bollards in this location and if they are required, relocate bollards to be out of the line of desire.</p>	<p>Solution: Repair paving to be even and suitable for disabled users.</p>	<p>Solution: Provide tactile paving at this crossing.</p>	<p>Solution: Provide crossing facilities at this location.</p>

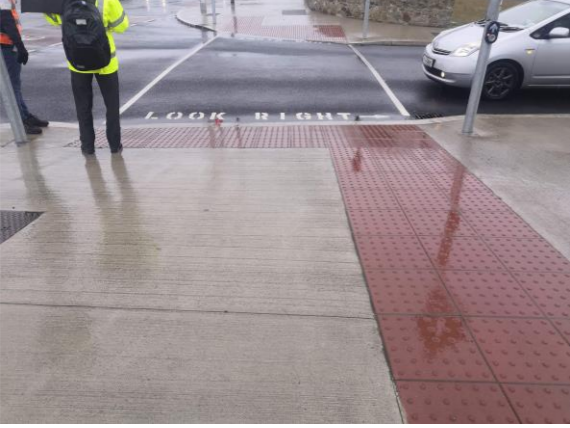
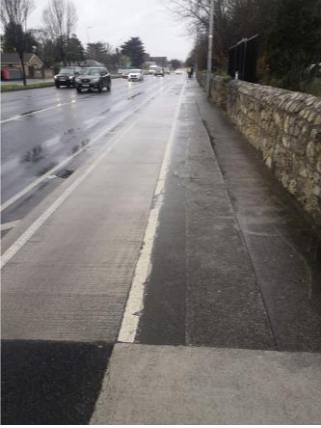
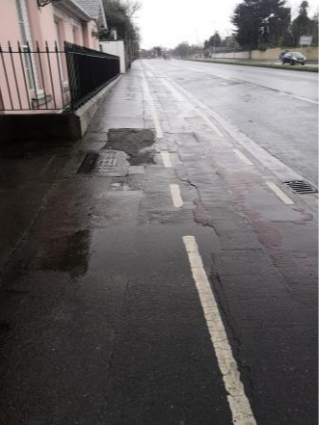
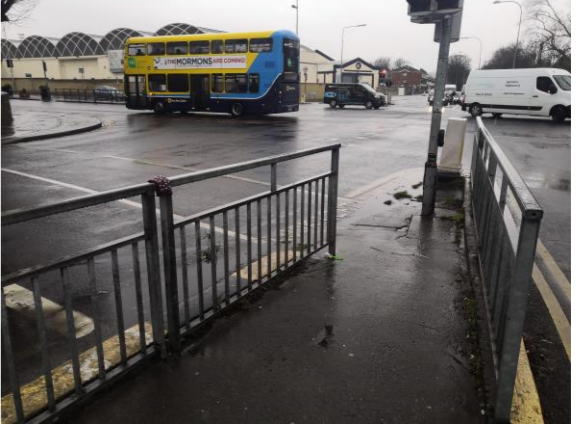
180 - Broken kerbing	183 - Insufficient footpath width	193 - No level difference between footpath and cycle lane	202 - No level difference between footpath and cycle lane
<p>This is located on Donnybrook Road. It is considered high severity due to the presence of a trip hazard which could result in a dangerous fall into the carriageway.</p>	<p>This is located on Donnybrook Road. It is considered high severity as it makes the path inaccessible to people using wheelchairs or walking aides.</p>	<p>This is located on Stillorgan Road south of the River Dodder crossing and to the west of the carriageway. It is considered high severity due to the risk of collision between pedestrians and cyclists.</p>	<p>This is located on Stillorgan Road to the west of the carriageway. It is considered high severity due to the risk of collision between pedestrians and cyclists.</p>

<p>718208, 730888</p>	<p>718085, 731018</p>	<p>717910, 731233</p>	<p>717802, 731363</p>
<p>Solution: Upgrade tactile paving to match the current standards.</p>	<p>Solution: Create delineation between the footpath and cycle path.</p>	<p>Solution: Create delineation between the footpath and cycle path.</p>	<p>Solution: Reposition street furniture to allow sufficient space for wheelchair users.</p>

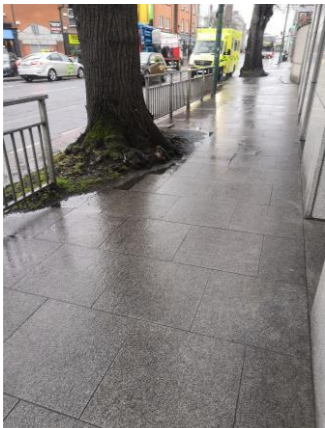
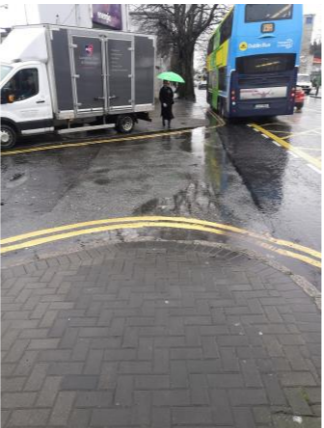
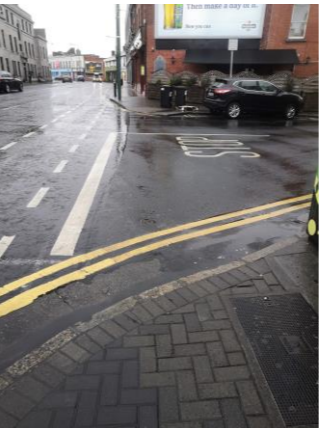
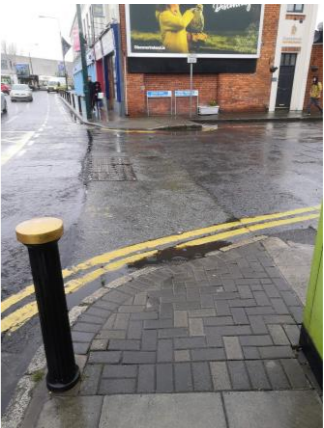
<p>Solution: Provide tactile paving at this crossing.</p>	<p>Solution: Repair paving to be even and suitable for disabled users.</p>	<p>Solution: Repair kerbing to be even and suitable for disabled users.</p>	<p>Solution: Repair paving to be even and suitable for disabled users.</p>
<p>236 - Broken paving / footway</p>	<p>239 - No crossing facilities provided</p>	<p>241 - No tactile paving at crossing</p>	<p>242 - No tactile paving at crossing</p>
<p>This is located on Donnybrook Road outside Energia Park. It is considered high severity due to the presence of a trip hazard which could result in a dangerous fall.</p>	<p>This is located on Donnybrook Road outside Bective Rangers Football Club. It is considered high severity as there are no alternatives to crossing at this point and it makes crossing inaccessible.</p>	<p>This is located on Donnybrook Road. It is considered high severity as a lack of tactile paving makes visually impaired pedestrians unaware of the presence of the crossing.</p>	<p>This is located on Donnybrook Road. It is considered high severity as a lack of tactile paving makes visually impaired pedestrians unaware of the presence of the crossing.</p>

<p>717635, 731525</p>	<p>717599, 731565</p>	<p>717588, 731584</p>	<p>717515, 731653</p>
<p>Solution: Repair paving to be even and suitable for disabled users.</p>	<p>Solution: Provide crossing facilities at this location.</p>	<p>Solution: Provide tactile paving at this crossing.</p>	<p>Solution: Provide tactile paving at this crossing.</p>
<p>243 - Inappropriately constructed vehicle crossover point</p>	<p>255 - Broken paving / footway</p>	<p>262 - Incorrect tactile paving at crossing</p>	<p>263 - Incorrect tactile paving at crossing</p>
<p>This is located on Donnybrook Road. It is considered high severity due to the risk of visually impaired pedestrians not</p>	<p>This is located on Morehampton Road. It is considered high severity due to the presence of a trip hazard which could result in a dangerous fall.</p>	<p>This is located on crossing Herbert Park at the junction with Morehampton Road. It is considered high severity as incorrect tactile paving makes visually impaired pedestrians unaware</p>	<p>This is located on crossing Morehampton Road at the junction with Herbert Park. It is considered high severity as incorrect tactile paving makes visually impaired pedestrians</p>

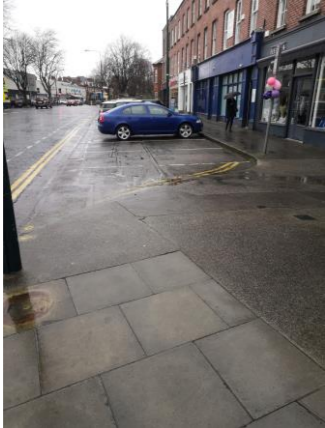
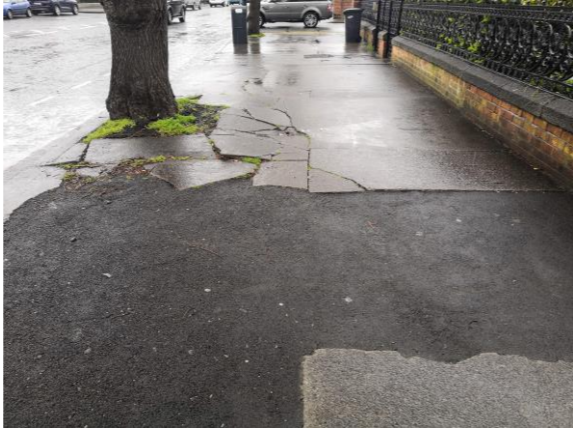
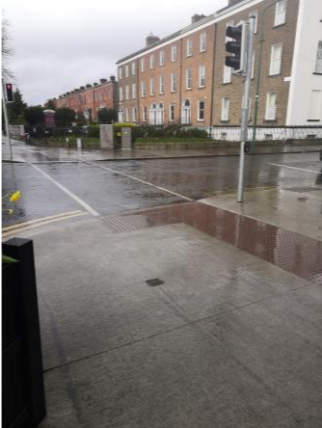
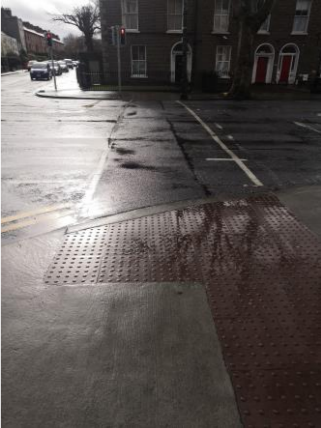
<p>being aware of the presence of a kerb and veering into the carriageway.</p>		<p>of the type of crossing and could lead to dangerous crossing movements.</p>	<p>unaware of the type of crossing and could lead to dangerous crossing movements.</p>

<p>717462, 731665</p>	<p>717369, 731769</p>	<p>717206, 731961</p>	<p>717192, 731965</p>
<p>Solution: provide a dropped kerb and tactile paving at this location.</p>	<p>Solution: Repair paving to be even and suitable for disabled users.</p>	<p>Solution: Upgrade tactile paving to match the current standards.</p>	<p>Solution: Upgrade tactile paving to match the current standards.</p>
<p>270 - Ponding</p>	<p>272 - Uneven paving / footway</p>	<p>275 - Uneven paving / footway</p>	<p>294 - Road Surfacing at Crossing Poor</p>
<p>This is located on Morehampton Road. It is considered high severity due to the large amount of ponding which makes the footway inaccessible and could mask other hazards.</p>	<p>This is located on Morehampton Road. It is considered high severity due to the presence of a trip hazard which could result in a dangerous fall.</p>	<p>This is located on Morehampton Road. It is considered high severity due to the presence of a trip hazard which could result in a dangerous fall.</p>	<p>This is located on Leeson Street Upper crossing Waterloo Lane. It is considered high severity due to the presence of a trip hazard on the road surface which could result in a fall in a dangerous location.</p>

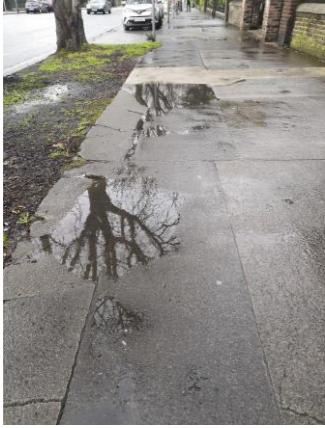
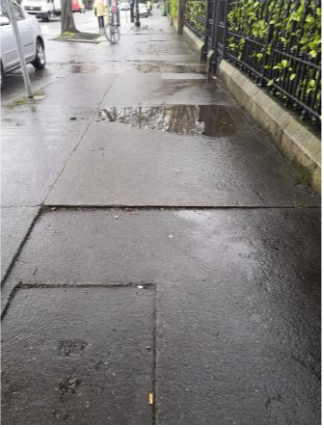
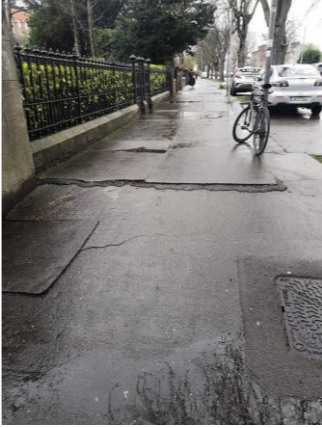
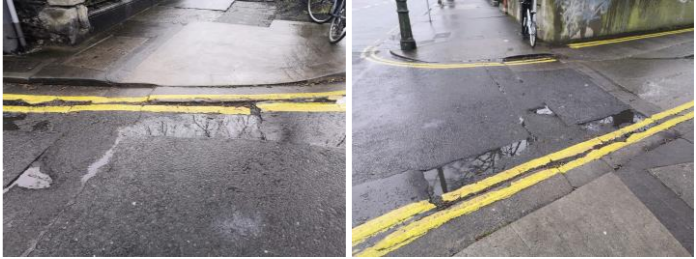
<p>717099, 732082</p>	<p>717088, 732097</p>	<p>717077, 732114</p>	<p>716796, 732366</p>
<p>Solution: Repair paving to be even and prevent ponding.</p>	<p>Solution: Repair paving to be even and suitable for disabled users.</p>	<p>Solution: Repair paving to be even and suitable for disabled users.</p>	<p>Solution: Repair paving to be even and suitable for disabled users.</p>
<p>296 - Broken paving / footway</p>	<p>300 - Incorrect tactile paving at crossing</p>	<p>301 - Incorrect tactile paving at crossing</p>	<p>303 - Inappropriately constructed vehicle crossover point</p>
<p>This is located on Leeson Street Upper at the junction with Appian Way. It is considered high severity due to the presence of a substantial hazard which could result in a dangerous fall.</p>	<p>This is located on Leeson Street Upper at the junction with Burlington Road. It is considered high severity as incorrect tactile paving makes visually impaired pedestrians unaware of the type of crossing and could lead to dangerous crossing movements.</p>	<p>This is located on Sussex Road at the junction with Leeson Street Upper. It is considered high severity as incorrect tactile paving makes visually impaired pedestrians unaware of the type of crossing and could lead to dangerous crossing movements.</p>	<p>This is located on Sussex Road. It is considered high severity due to the risk of visually impaired pedestrians not being aware of the presence of a kerb and veering into the carriageway.</p>

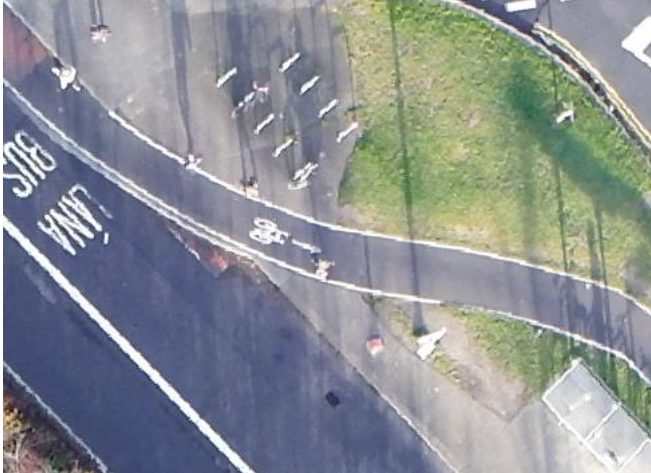
<p>Boosterstown Woodbine Road Bus Stop 2007: There is no tactile paving to indicate the need to cross the cycle path. There is also no provision to indicate priority.</p>

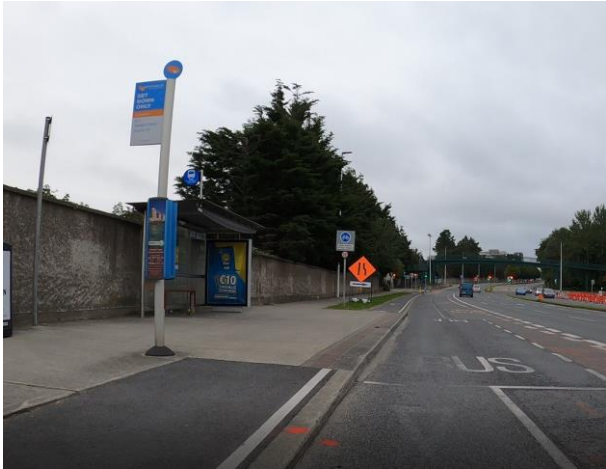
<p>Radisson Hotel Bus Stop 2009: The cycle path becomes shared space in front of the bus shelter without any tactile paving to indicate pedestrians need to cross the cycle path to access a bus. There is also no provision to indicate priority.</p>

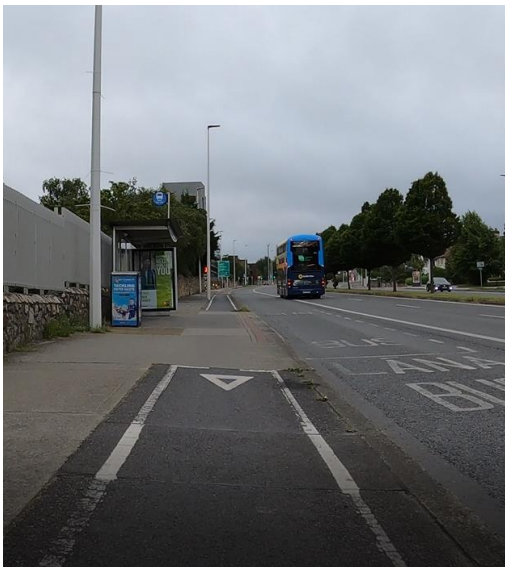
<p>Boosterstown Avenue Bus Stop 2010: The cycle path becomes shared space in front of the bus shelter without any tactile paving to indicate pedestrians need to cross the cycle path to access a bus. There is also no provision to indicate priority.</p>

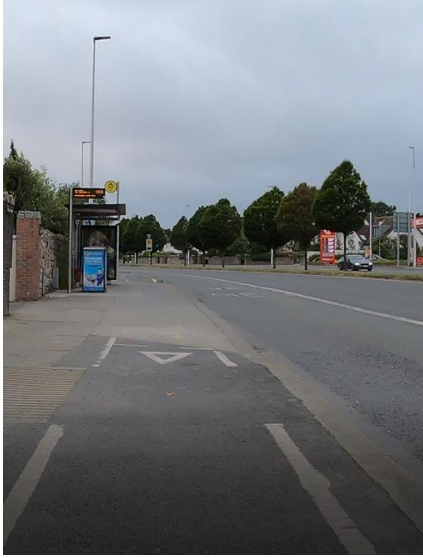
<p>Sycamore Crescent Bus Stop 435: The cycle path becomes shared space in front of the bus shelter without any tactile paving to indicate pedestrians need to cross the cycle path to access a bus. There is also no provision to indicate priority.</p>

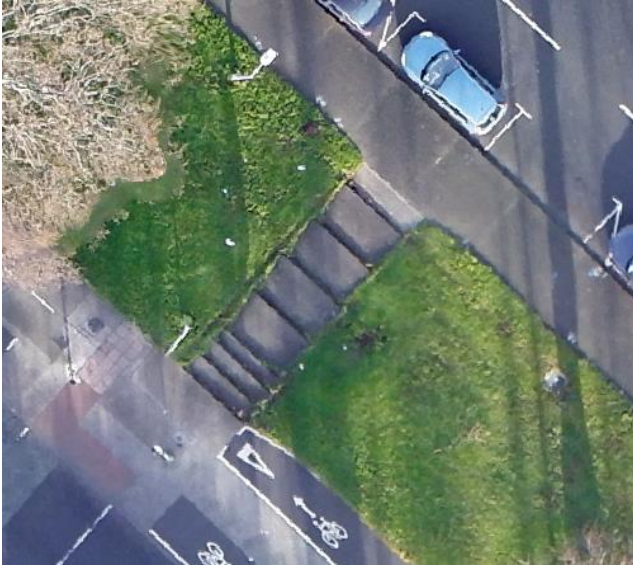
Figure 3.6: No tactile paving to indicate stairs

There are some stairs at the interchange at UCD which do not have tactile paving to indicate that they are there.

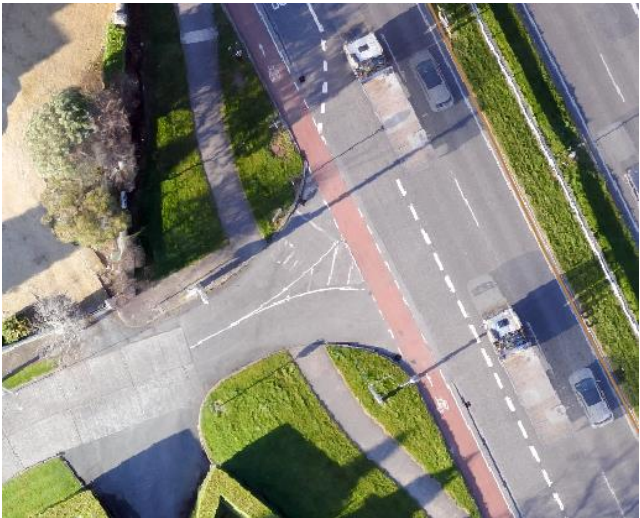
Table 3.2: Junctions missing tactile paving

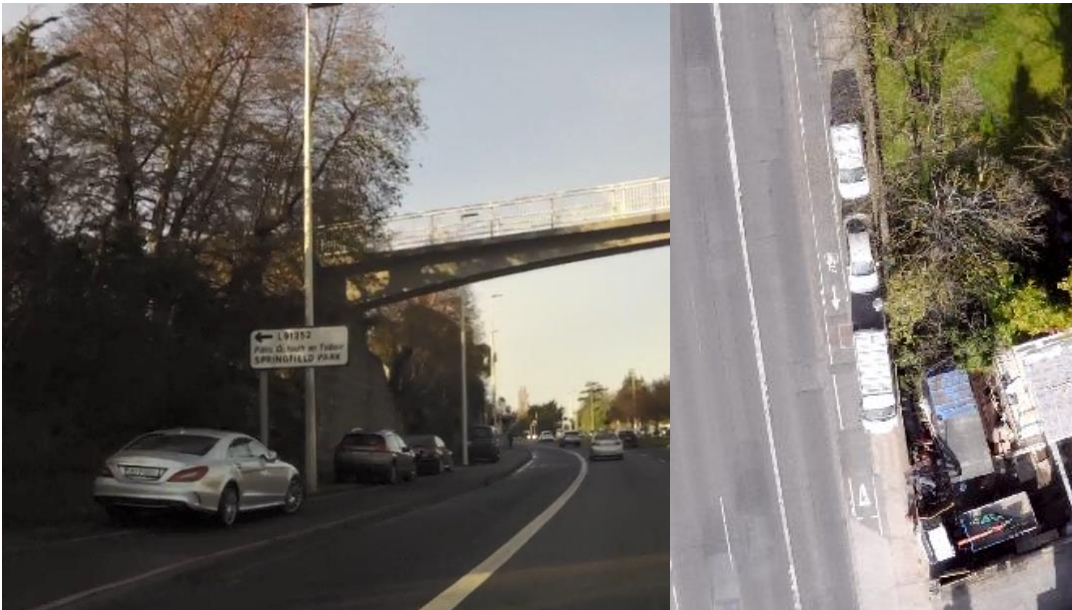
There is no on street parking along Section 2, which leads to some instances of vehicles parked on the footpath. A separate parking survey is being carried out and should identify areas of high demand where parking may need to be supplied elsewhere.

Figure 3.8: Vehicles parked on footpath. Left Image: Northbound carriageway on the northern arm of the Kill Lane junction. Right Image: Southbound Carriageway north of bus stop 435

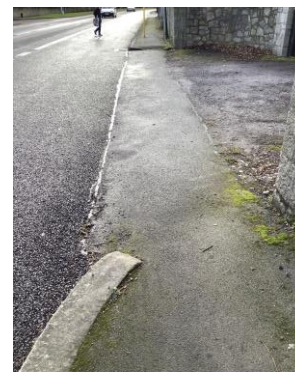
Of the 182 issues identified in section, 83 are related to footpaths. There are 23 instances of broken or uneven footpath, three instances of broken kerbing and one instance of ponding. There are three sections of this section with no footpath provided, aside from those in Figure 4.4, 16 instances of insufficient footpath width and three pieces of inappropriate street furniture. There is one instance of no dropped kerb being provided at the start of the footpath network and there were 33 inappropriately constructed vehicle crossover points, such as the one in Figure 4.5.

Figure 4.5: Inappropriate vehicle crossover
