Bray to City Centre Core Bus Corridor Scheme June 2023

Preliminary Design Report

Appendix F Structures Reports

Appendix F7 St Annes Retaining Wall Record of Structural Review

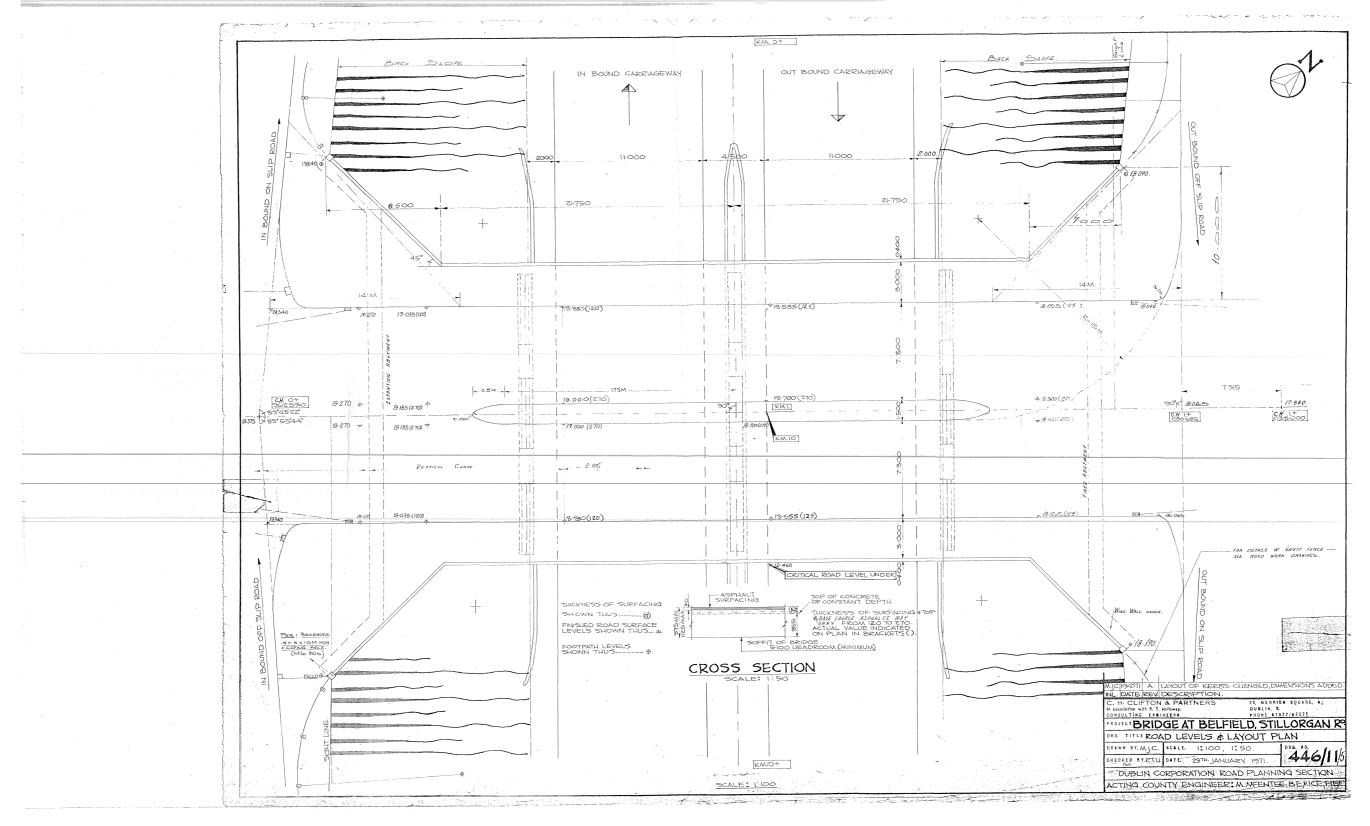
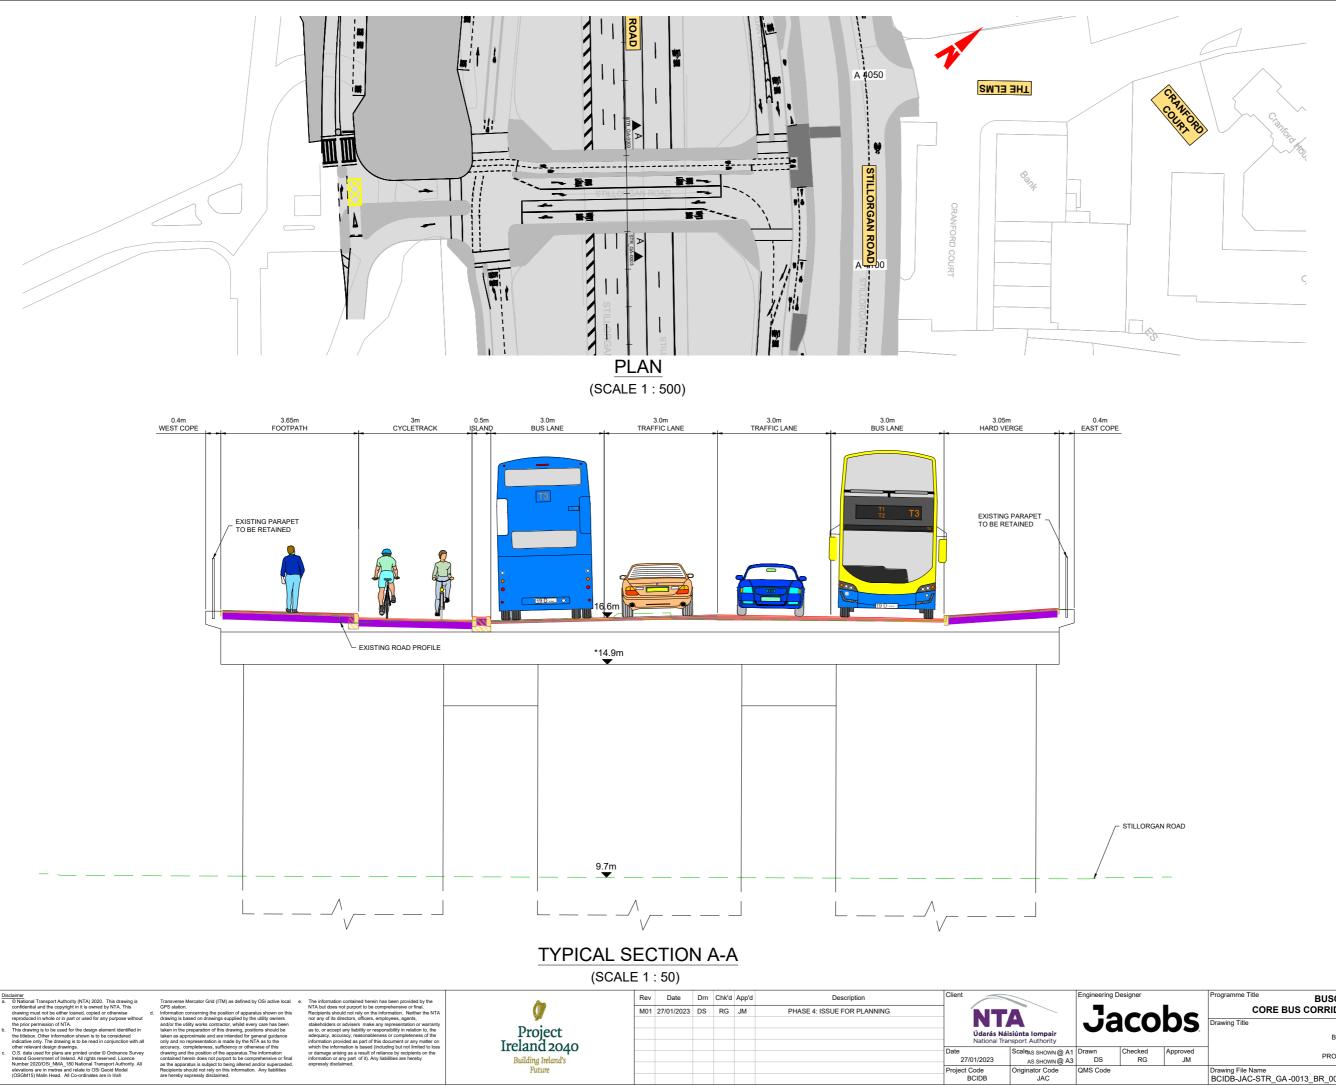
Appendix A – Plan Arrangement

"Design of Road Restraint System for Constrained Locations (Online Improvements, Retrofitting and Urban Settings), given the recent collision. A record of this risk assessment is included in Appendix C.
Conclusion	Defects in the structure have arisen due to poor construction quality, namely low cover resulting in reinforcement corrosion and subsequent concrete spalling. None of the identified defects appear to originate from overstressing of the structure so it can be concluded that the structure in its current arrangement is performing adequately with no signs of distress.
	It has been identified that the prestressed beams and transverse deck would both experience a small increase in bending in the order of 1% but this is not considered significant enough to warrant the intrusive investigations needed to confirm capacities.
	A risk assessment has been undertaken following DMRB CS461 to confirm the adequacy of the existing parapets and has concluded that no further intervention is required.

The change in highway alignment will not have a detrimental impact on the bridge therefore no further structural investigations are required. Recommendations for on-site investigations as per the previous revision no longer apply.

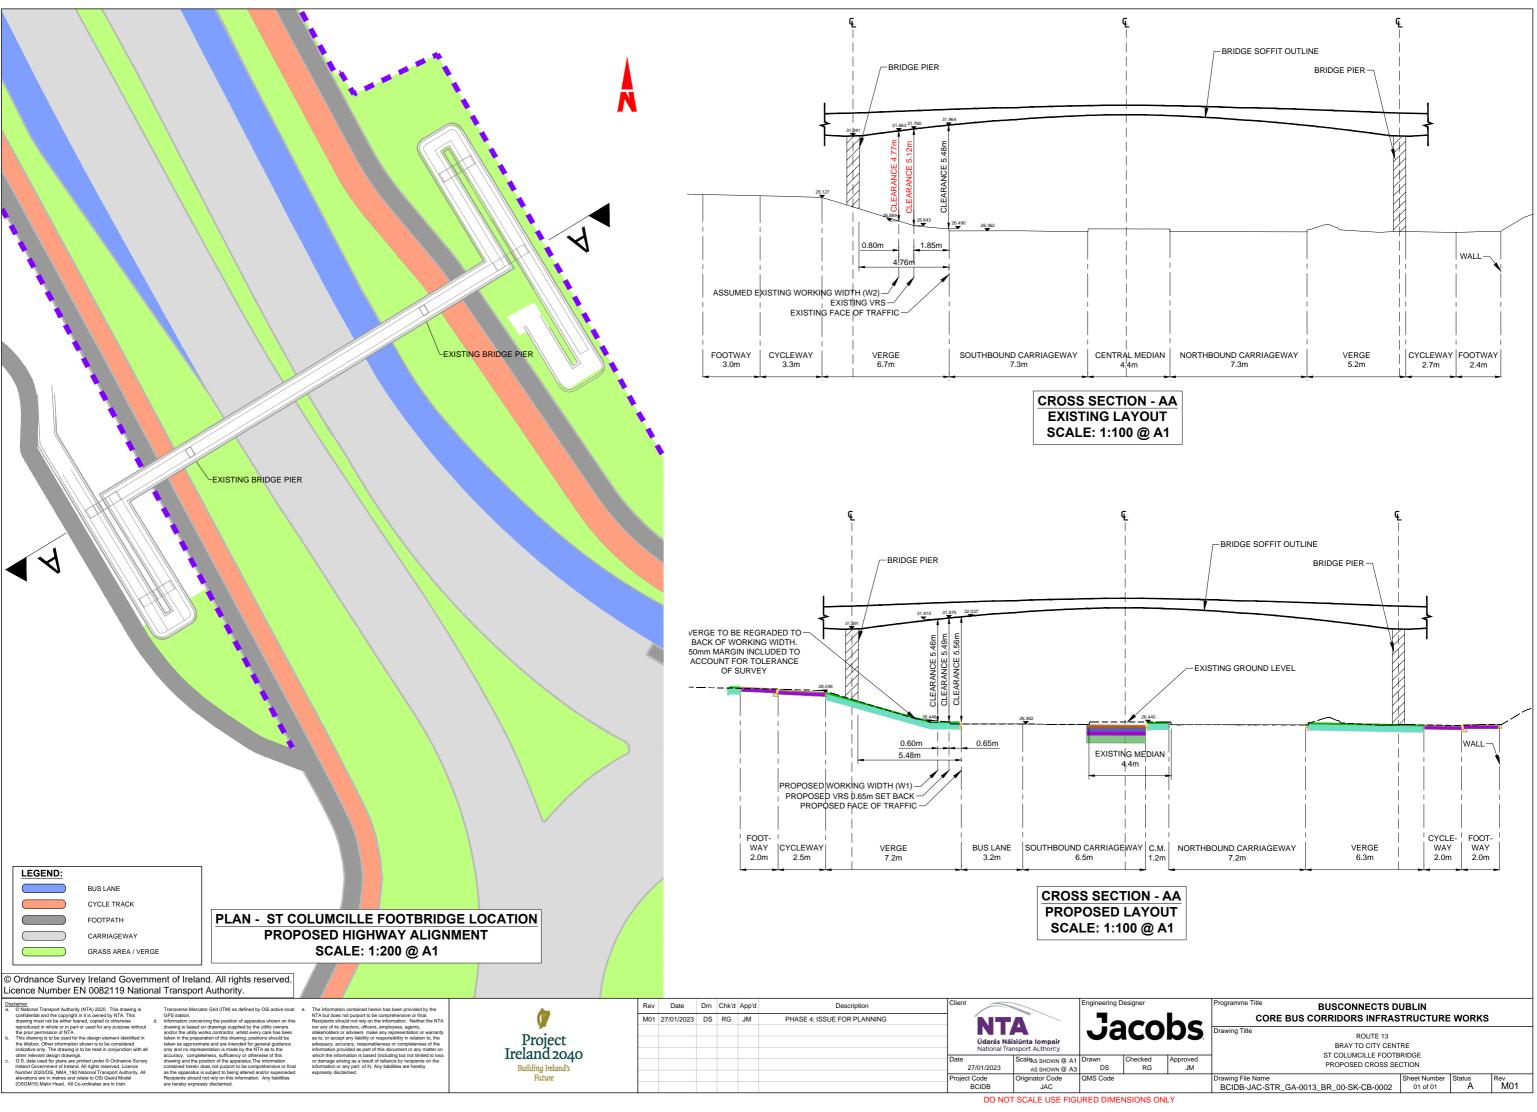
Appendix A – General Arrangement

is no proposed modification to the east carriageway as part of the BusConnects scheme.
Change in Standards	This structural review has not been prepared in response to a change in standards.
Change in Loading	This structural review has not been prepared in response to a change in loading.
Conclusion	The bridge is currently in good condition and is performing adequately with no signs of distress.
	The existing arrangement possesses a substandard vertical clearance at the east verge and without further intervention the proposed alignment would also result in a substandard vertical clearance. The existing arrangement on the west verge results in a substandard headroom at the back of the assumed existing working width. There is no proposed works to the west verge as part of the BusConnects scheme.
	The proposed alignment moves the face of traffic 0.7m away from the east pier and includes the introduction of a W1 VRS barrier and a local regrading of the verge. The proposed alignment will provide the required clearance to the back of the VRS working width, complying with DN-GEO-03036 Section 6.2e. This is an improvement on the vertical clearance to the existing structure.

Measures to achieve the required headroom should be undertaken through the introduction of a VRS, with a W1 working width (0.6m) positioned 0.65m from the face of traffic in the southbound carriageway. The verge should also be levelled to the back of the VRS working width and regraded up to the east pier face such that there is no risk of damage to the pier waterproofing. This results in a headroom of 5.46m at the back of the working width of the VRS which is compliant with the requirements of DN-GEO-03036 Section 6.2e. Works to regrade the verge would not impact bridge foundations, which lie approximately 2.4m below the carriageway level based on historical drawings, or underground utilities.

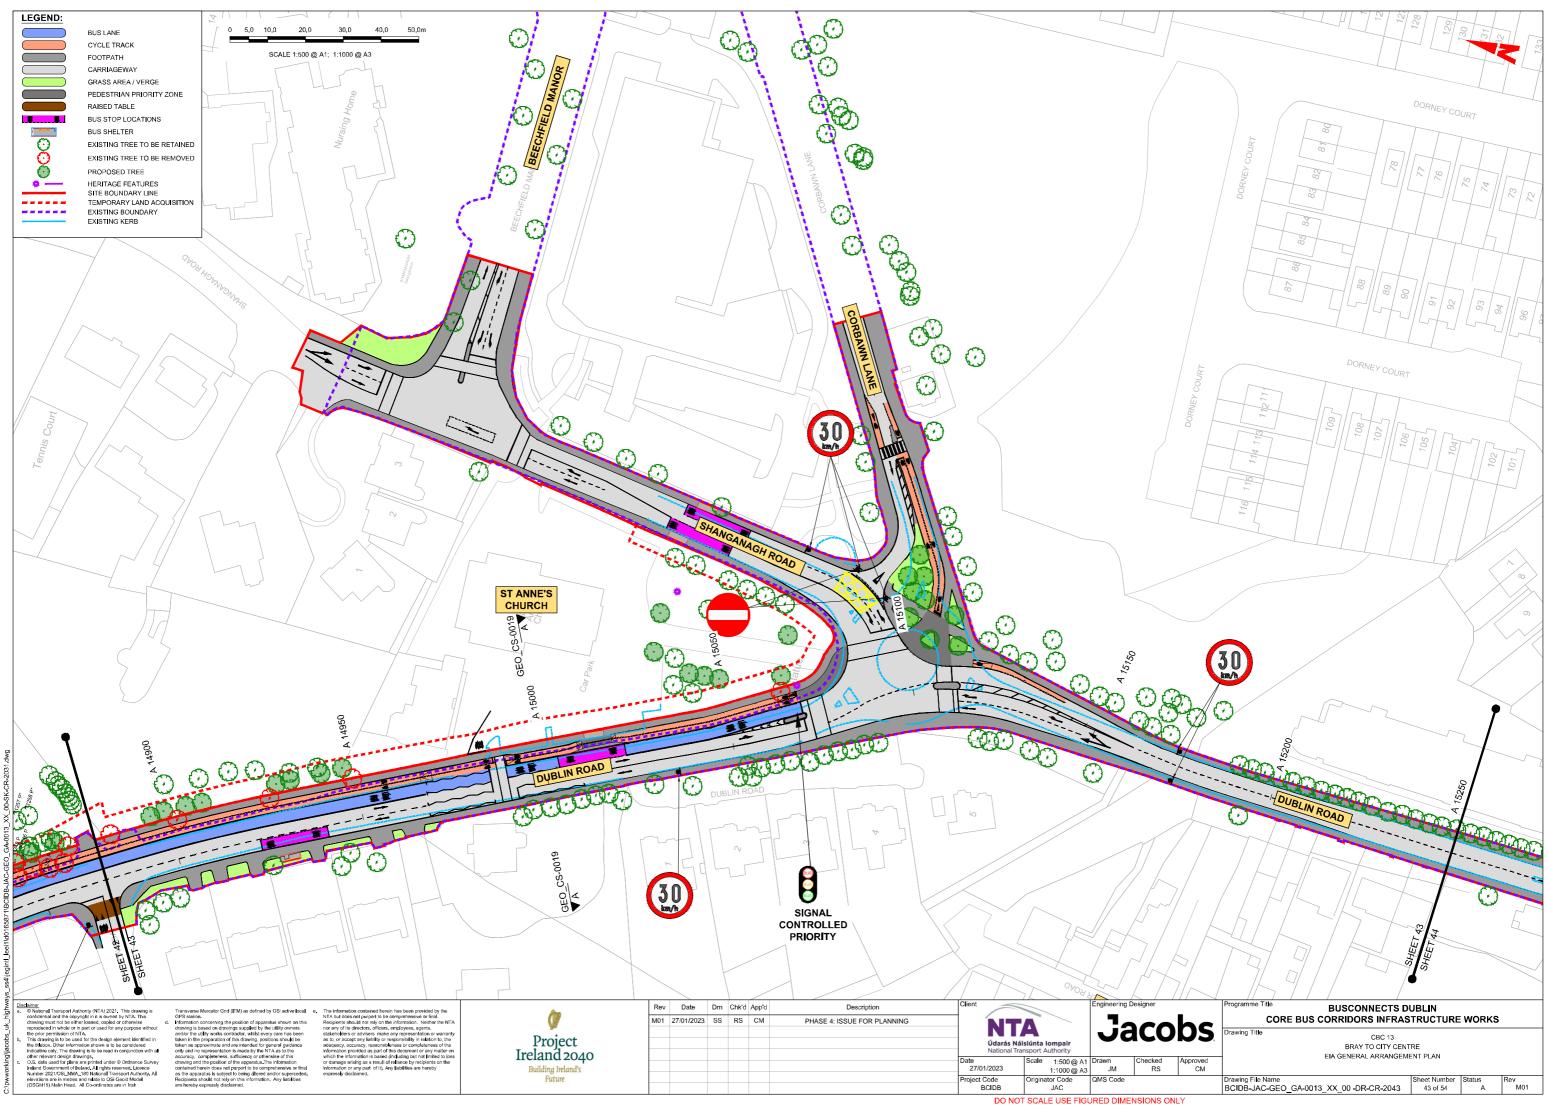
Appendix A – Proposed Highway Alignment

Conclusion	In accordance with AM-STR-06015 clause 2.7 the general approach to retaining walls is as follows "Generally, substructures and foundations, retaining walls and buried structures need not be assessed by calculation unless there are evident signs of movement or cracking determined from an inspection for assessment or any other inspection of the structure, or where traffic loading has a significant effect on the structure."
	None of the observed defects appear originate from overstressing and the structure appears to be performing adequately with no obvious signs of distress. There is no evidence of movement or propagation of cracks identified on visual inspection. However, it should be noted that not all of the structure could be observed due to vegetation.
	The new arrangement will bring highway loading closer to the walls on both sides of the carriageway. This is likely to have a negligible impact on the West wall due to the small retained height resulting in no expected traffic surcharge. However, there is an expected increase in traffic loading on the East structure in comparison to the existing arrangement. This would constitute a significant change in loading which should be confirmed quantitively.

It is recommended that the following investigative works are carried out to allow a more detailed consideration of the impact to the two retaining walls:

- It is recommended that removal of vegetation is carried out to allow for a complete visual "inspection for assessment" of the full extent of the walls.
- Additional topographical surveys are required on either side of the walls to confirm retained height and parapet height along the full length.
- Geotechnical investigations are required to confirm composition and properties of backfill to determine distribution of highways loads.
- Structural investigations should be undertaken to confirm thickness of the walls at various depths, plus strengths and densities of materials.

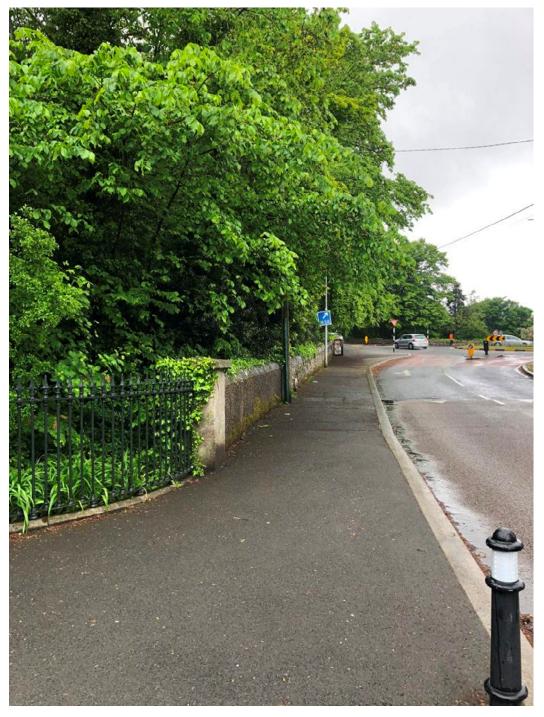
Figure 1 View of east wall looking north

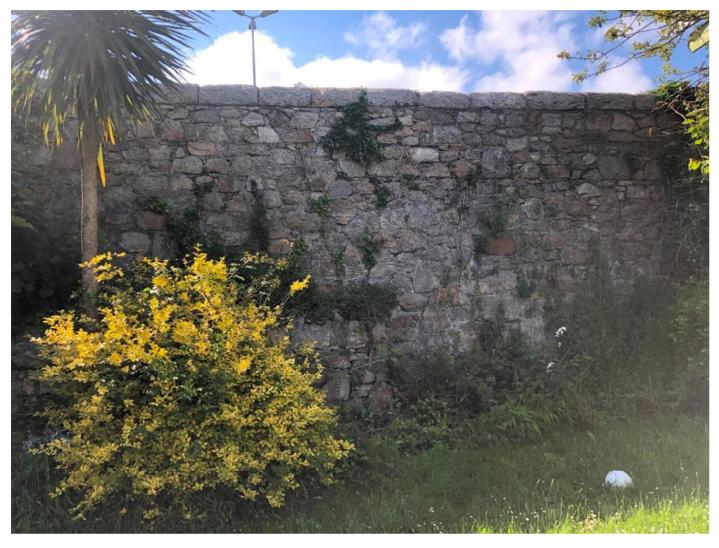
Figure 14 View of west elevation
